TEST REPORT NON-LOADBEARING WALL

Name of sponsor:	Nordic Build A/S		
Product name:	Non-loadbearing facade element		
File no.:	PGA11339A	Revision no.:	0
Test date:	10-12-2018	Date:	29-01-2019
Pages:	10	Encl.:	41
Ref:	RBI / ADR

Examination of the fire-resistance of a Non-loadbearing facade element.

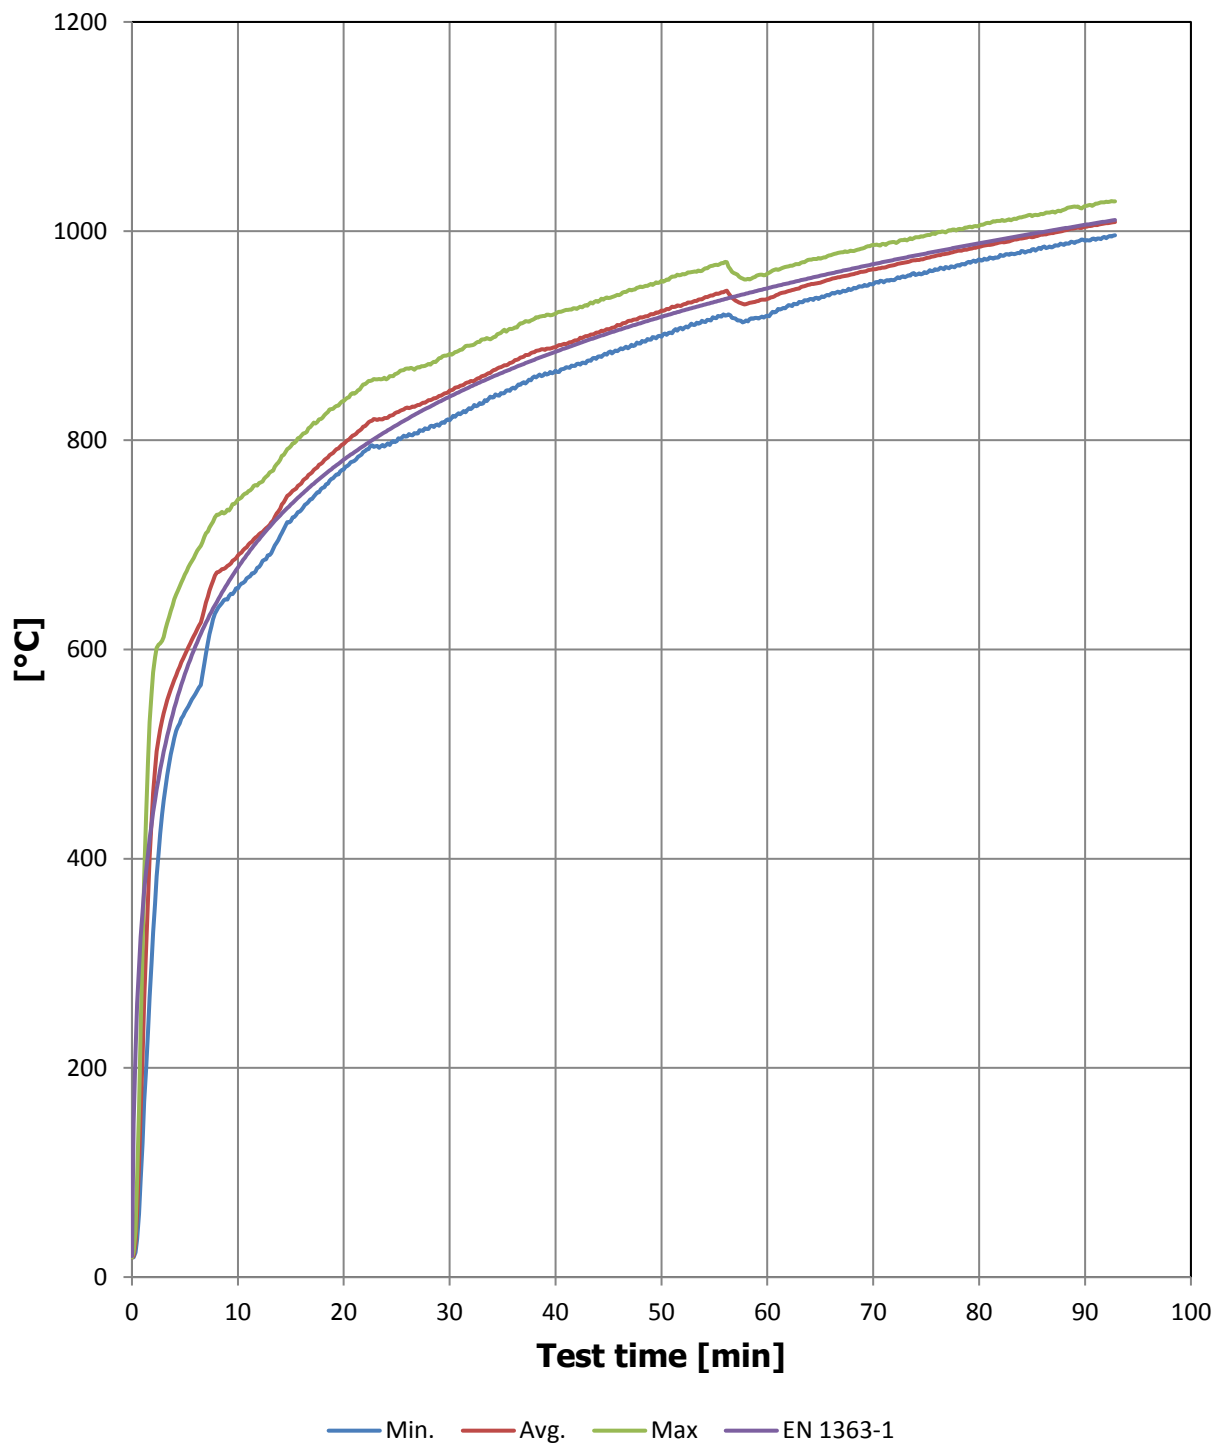
Furnace temperature

Time Minutes	Measured			Norm EN 1363-1	Area under curve		Dev. [%]	Limit [%]
	Minimum	Average	Maximum		Measured	EN 1363-1		
0	19	19	19	20	0	0	0,0	
3	456	539	612	502	944	1115	-15,3	
6	558	616	691	603	2690	2790	-3,6	15
9	648	680	734	663	4655	4695	-0,9	15
12	679	710	759	705	6739	6750	-0,2	14
15	723	750	794	739	8923	8918	0,1	13
18	755	779	822	766	11217	11176	0,4	11
21	780	805	845	789	13595	13508	0,6	10
24	796	821	858	809	16042	15904	0,9	8
27	807	834	870	826	18527	18357	0,9	7
30	819	848	883	842	21047	20859	0,9	5
33	835	861	896	856	23609	23406	0,9	5
36	850	875	907	869	26214	25994	0,8	5
39	864	887	919	881	28860	28619	0,8	4
42	873	895	926	892	31533	31279	0,8	4
45	884	906	936	902	34237	33971	0,8	4
48	893	918	947	912	36973	36692	0,8	4
51	902	928	957	921	39739	39442	0,8	3
54	913	936	964	930	42533	42218	0,7	3
57	916	934	959	938	45350	45019	0,7	3
60	919	935	959	945	48147	47844	0,6	3
63	933	945	968	953	50969	50691	0,5	3
66	940	954	977	960	53819	53559	0,5	3

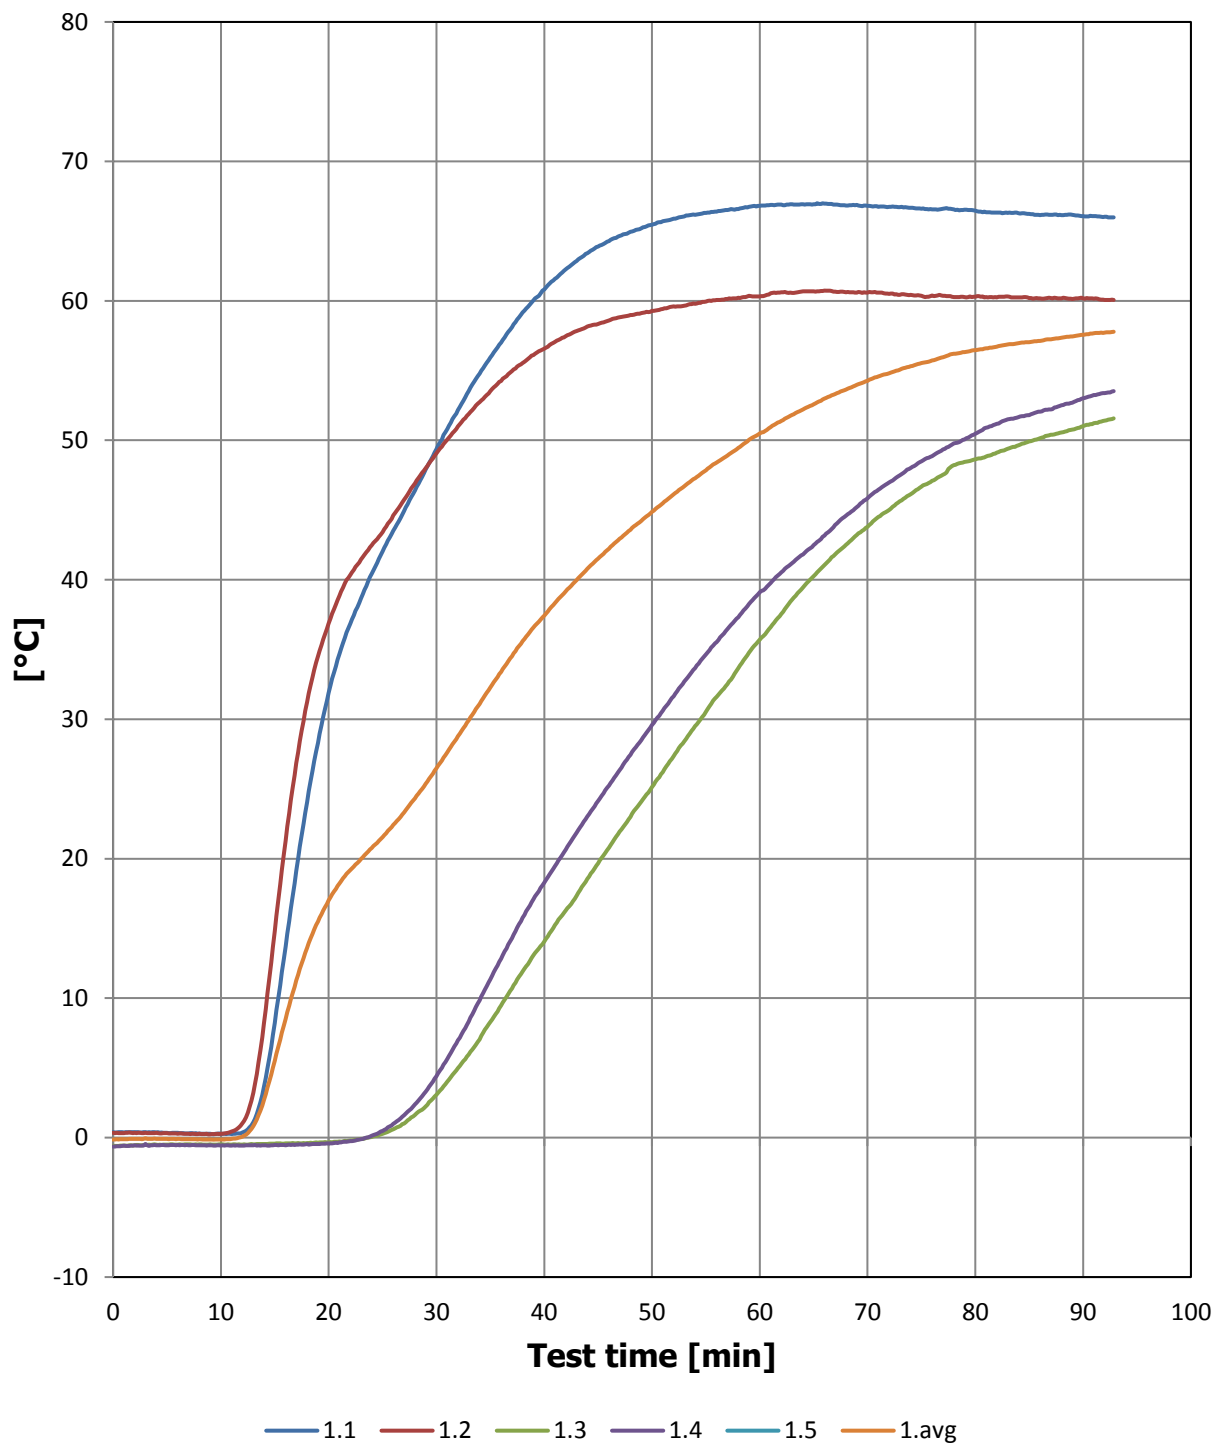
Measured with 5 thermocouples

Average temperature rise

Min. / °C	1.1	1.2	1.3	1.4	1.5	1.Avg	1.Max
0	0	0	-1	-1	0	0	0
3	0	0	0	0	0	0	0
6	0	0	0	-1	0	0	0
9	0	0	0	-1	0	0	0
12	0	1	-1	-1	0	0	1
15	8	15	0	-1	0	6	15
18	24	31	0	0	0	14	31
21	35	39	0	0	0	18	39
24	40	42	0	0	0	21	42
27	45	46	1	2	0	23	46
30	49	49	3	4	0	26	49
33	54	52	6	8	0	30	54
36	57	54	9	13	0	33	57
39	60	56	13	17	0	37	60
42	62	57	16	21	0	39	62
45	64	58	20	24	0	42	64
48	65	59	23	27	0	44	65
51	66	59	26	31	0	45	66
54	66	60	30	34	0	47	66
57	67	60	33	36	0	49	67
60	67	60	36	39	0	50	67
63	67	61	39	41	0	52	67
66	67	61	41	43	0	53	67
69	67	61	43	45	0	54	67
72	67	60	45	47	0	55	67
75	67	60	47	48	0	56	67
78	67	60	48	50	0	56	67
81	66	60	49	51	0	57	66
84	66	60	50	52	0	57	66
87	66	60	50	52	0	57	66
90	66	60	51	53	0	58	66
92	66	60	51	53	0	58	66

Failure [min]	-	-	-	-	-	-	-
Failure °C	180	180	180	180	180	140	180

- Failure of insulation did not occur during the test
- The average temperature rise on the unexposed surface of the test specimen did not exceed 140 °C during the test
- The maximum temperature rise on the unexposed surface of the test specimen did not exceed 180 °C during the test
