Test Report

Loadbearing roof

Name of sponsor: Nordic Build A/S
Product name: Loadbearing roof
File no.: PGA11340A
Test date: 16-01-2019 **Date:** 28-01-2019
Pages: 10 **Encl.:** 44
Ref: RBI / ADR

Examination of the fire-resistance of a loadbearing and separating roof.

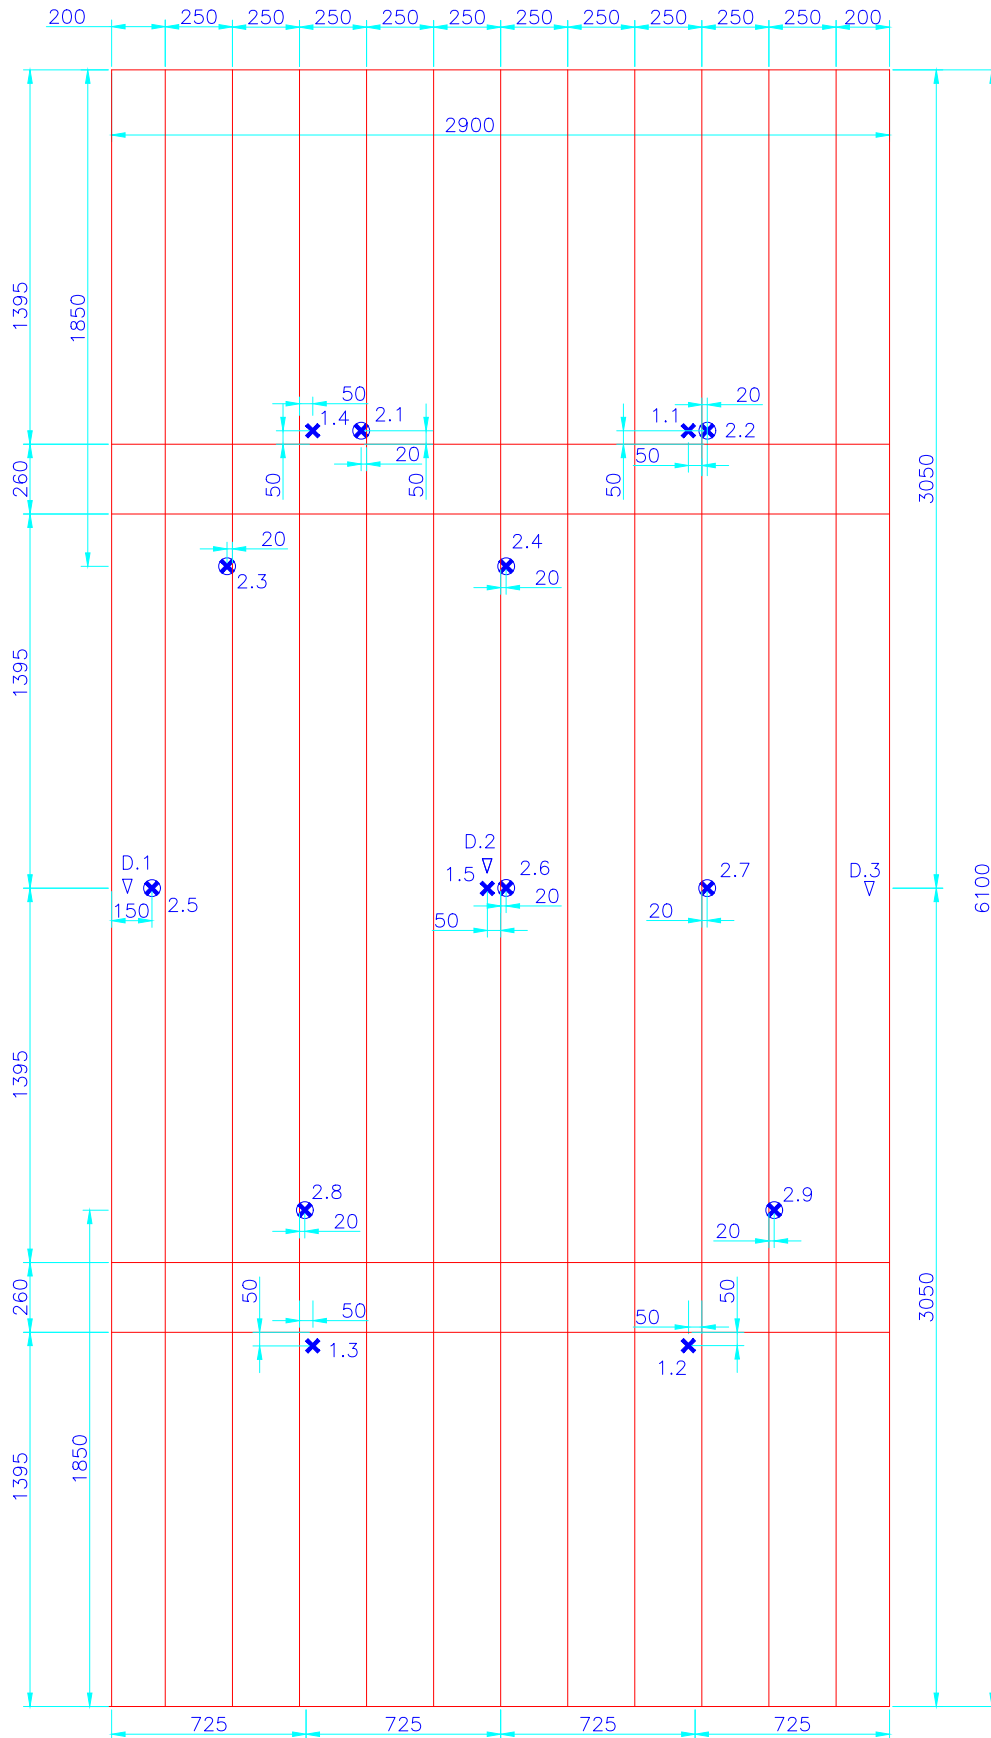
File No.: PGA11340A
 Test date: 16-01-2019
 Enclosure: 1.1

- ✕ Thermocouple placed on the unexposed surface (average)
- ⊗ Thermocouple placed on the unexposed surface (maximum)
- ∇ Deflection measuring point

All measurements are in mm

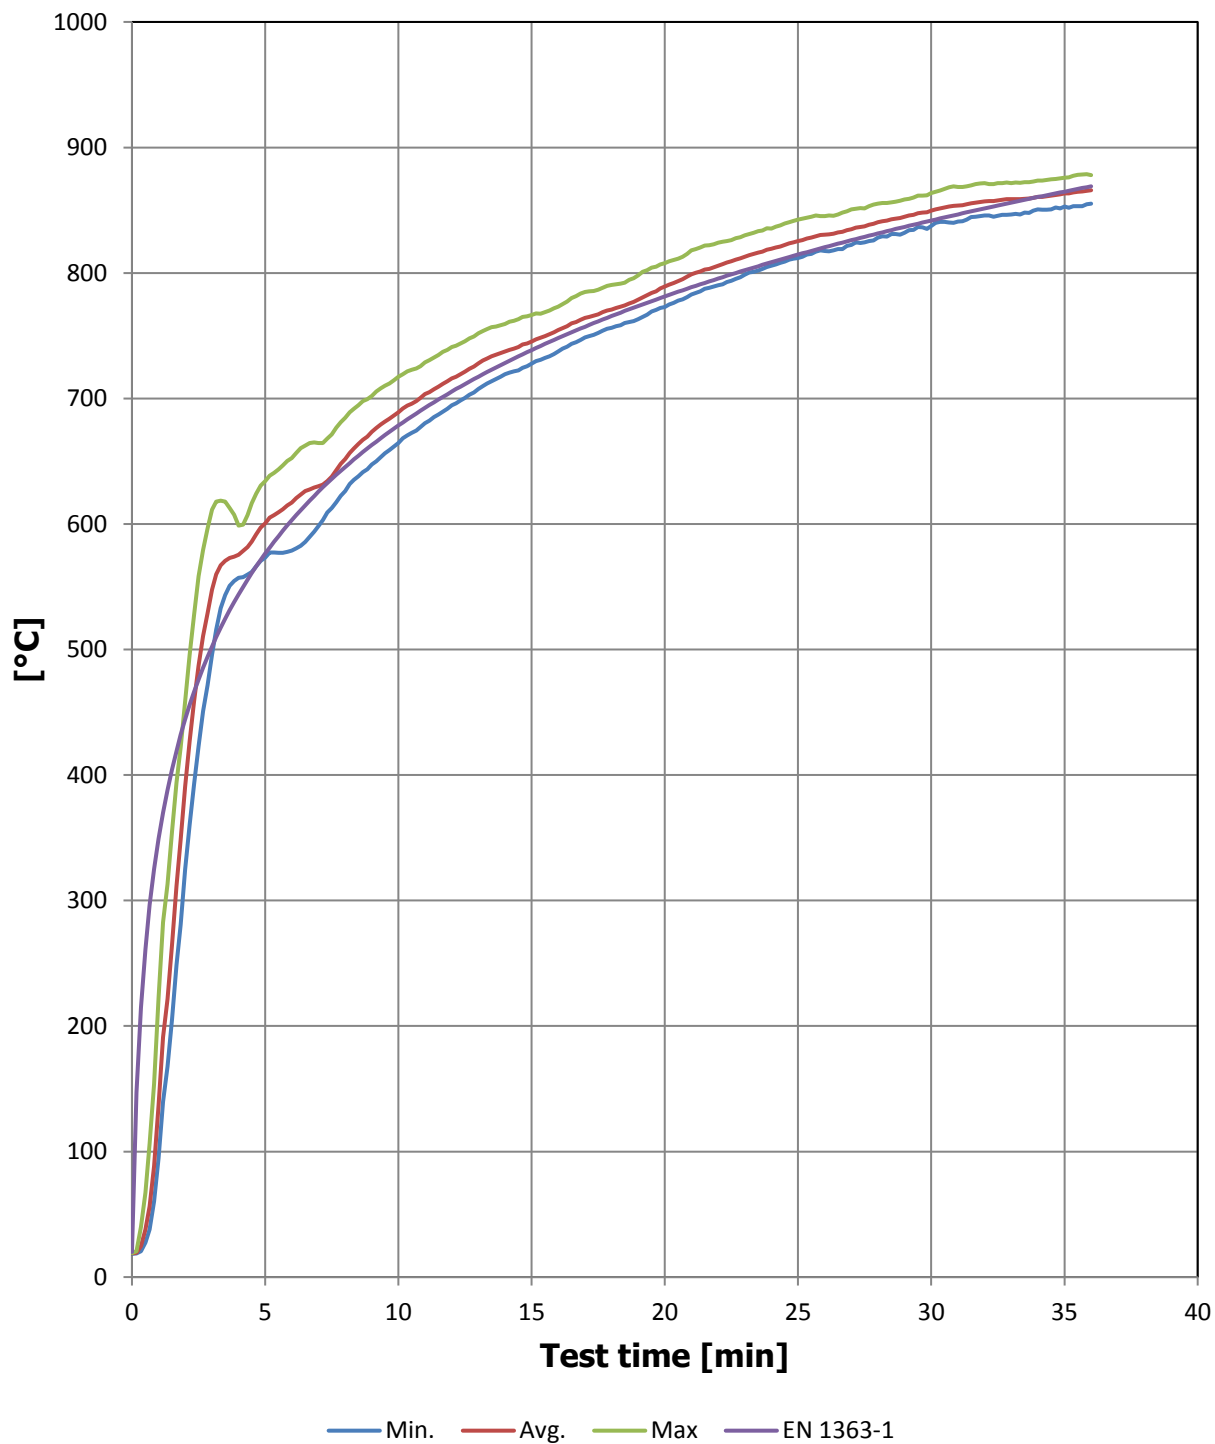
Furnace

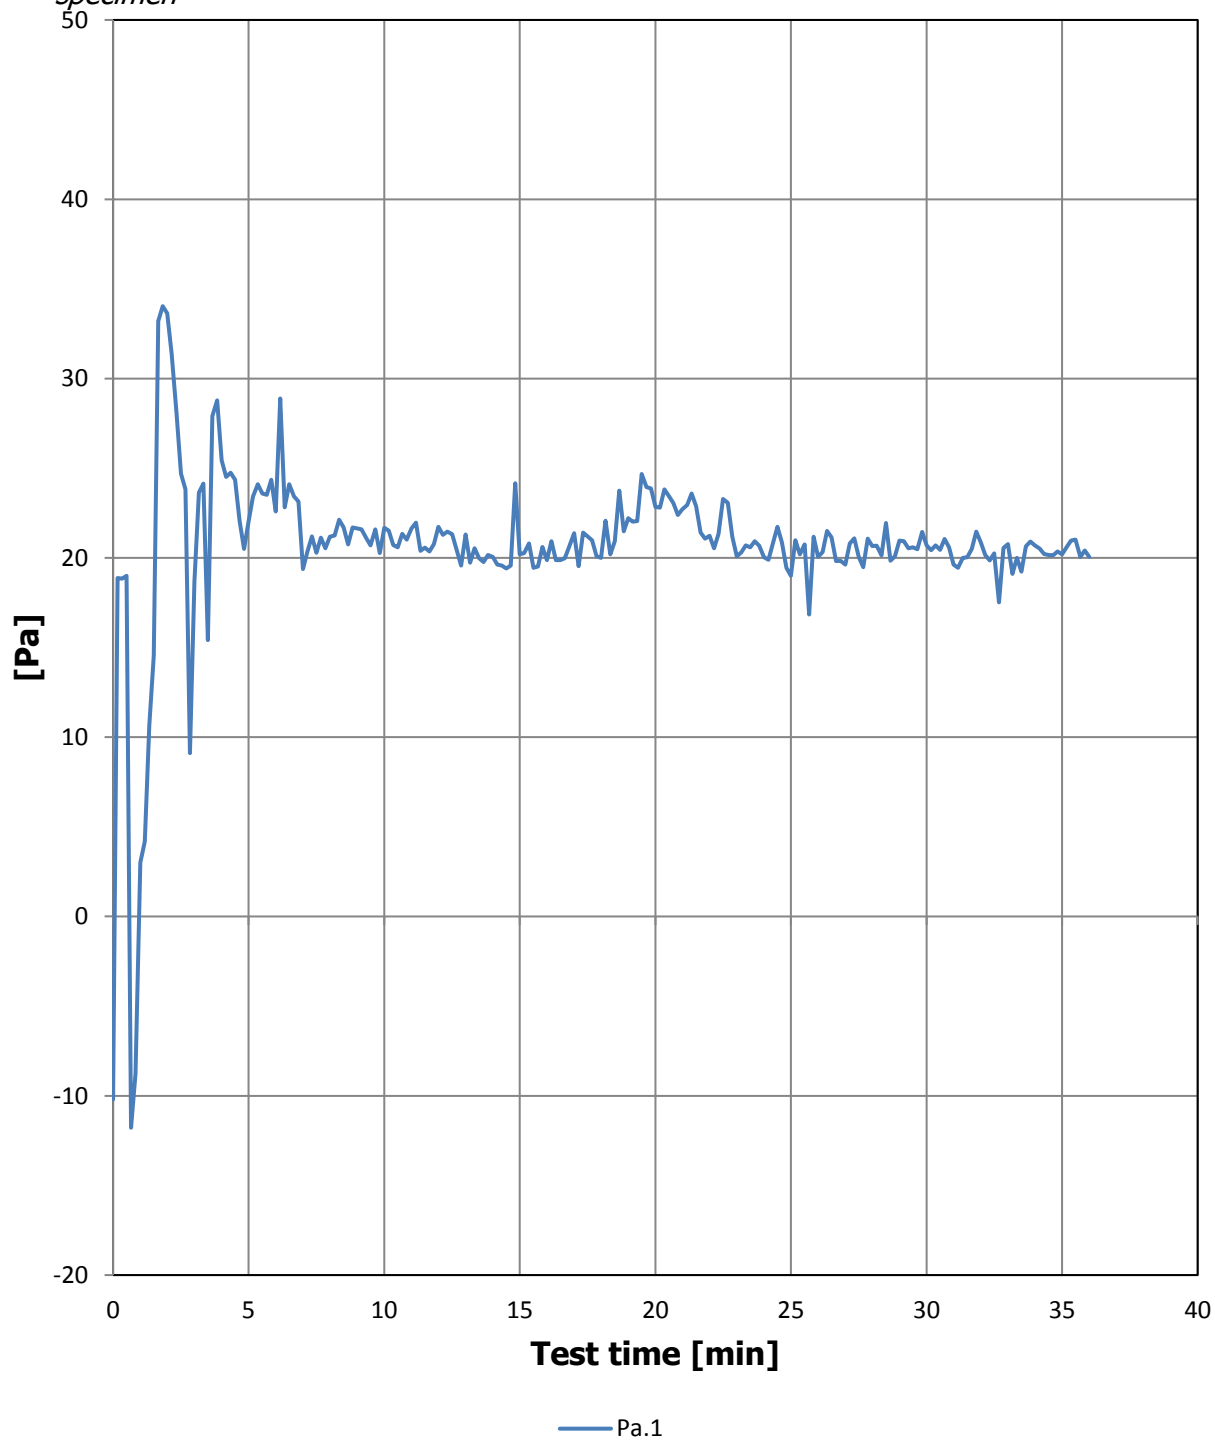
Horizontal furnace pressure

The differential pressure in the furnace during the test, measured 100 mm below the test specimen

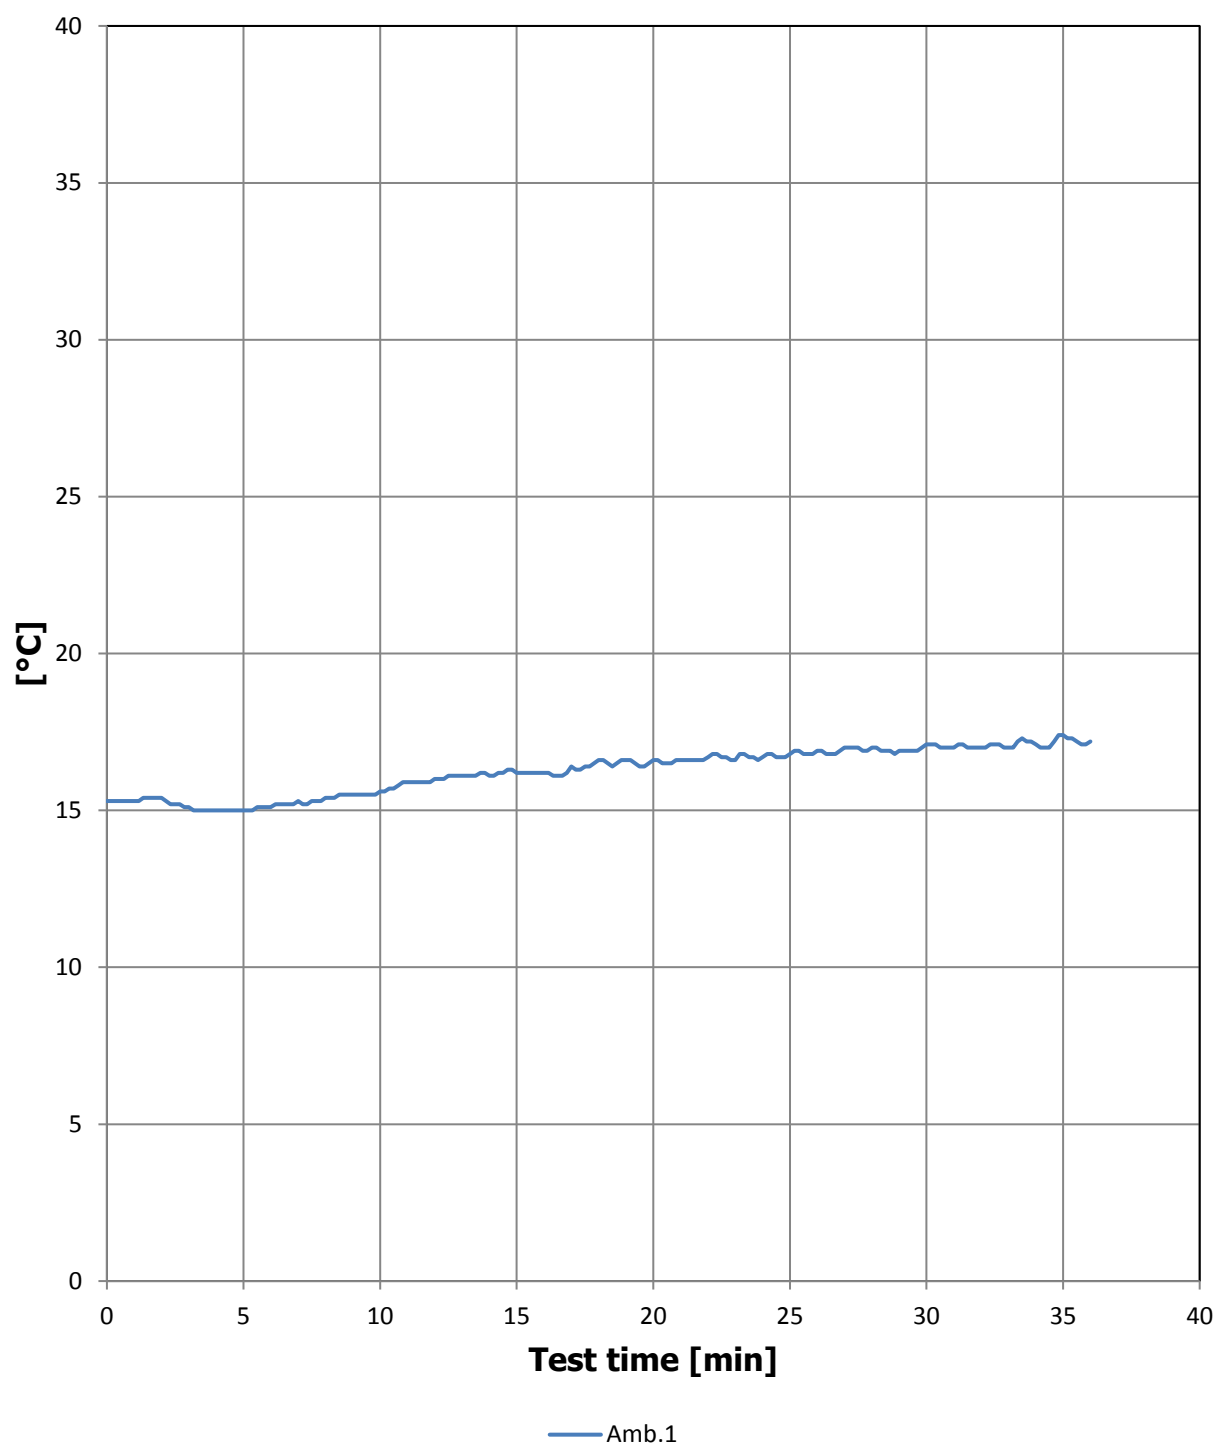
Ambient temperature

The ambient temperature in the laboratory during the test

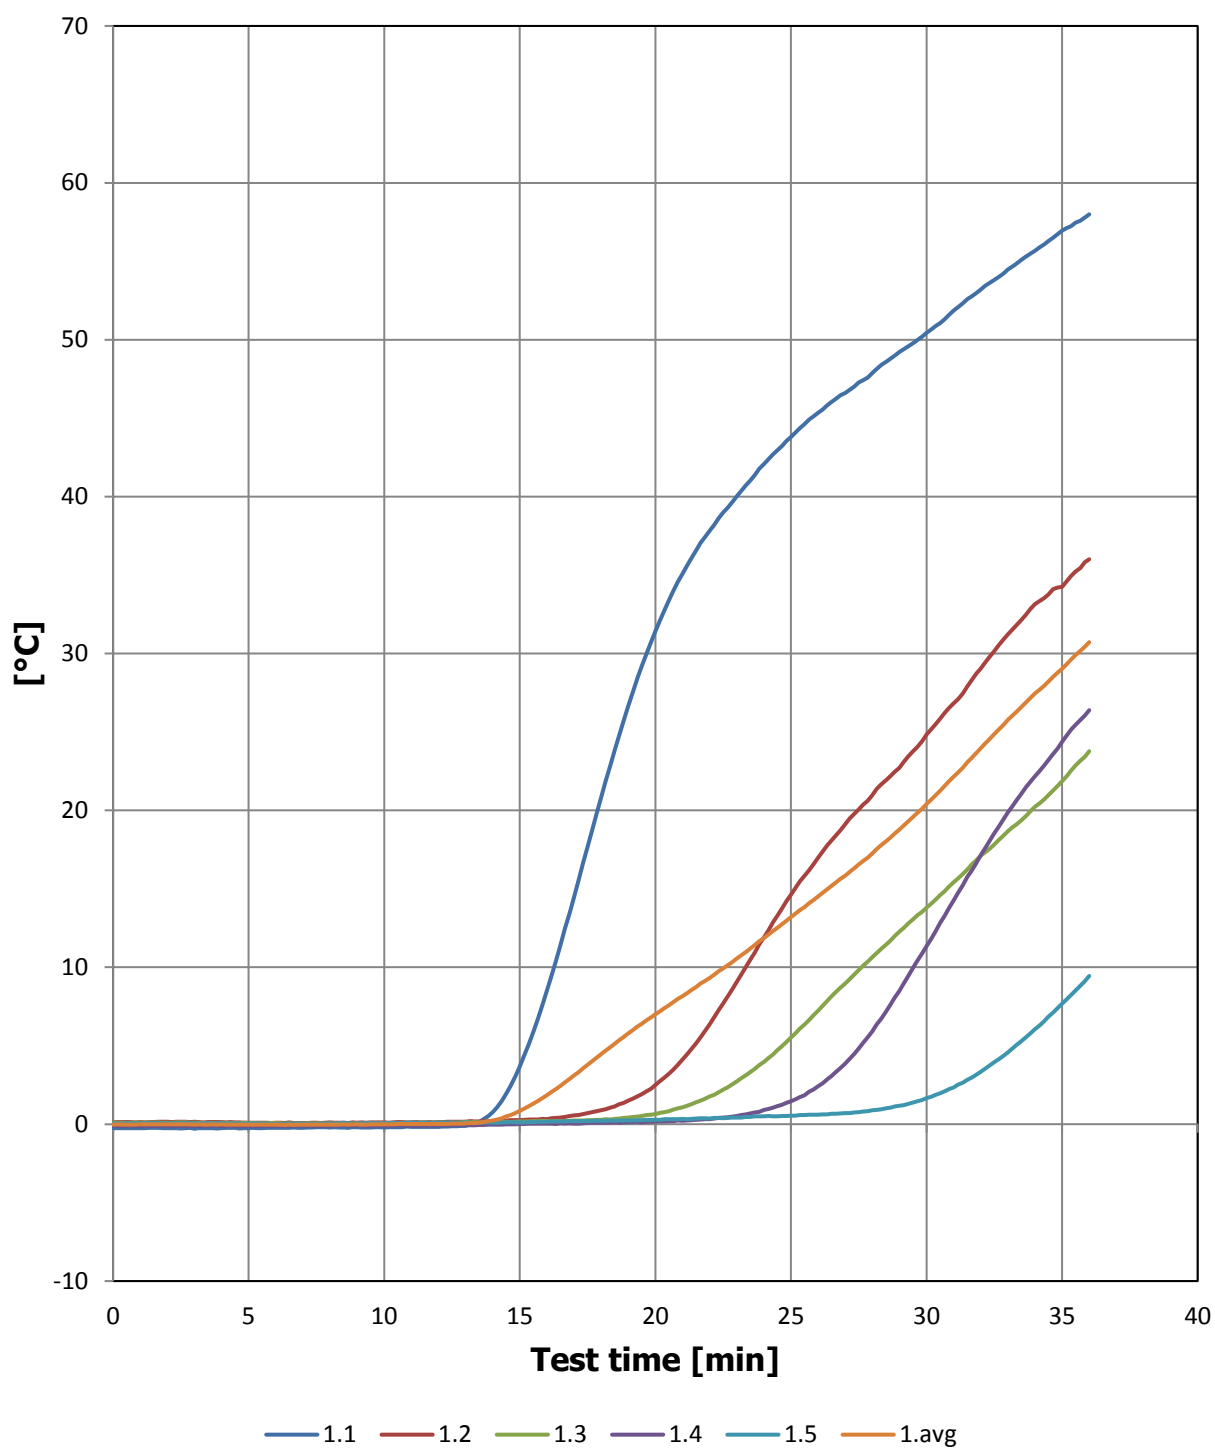
Average temperature

Temperature rise on the unexposed side

- During the test no failure of insulation occurred to failure of integrity
- The average temperature rise on the unexposed surface of the test specimen did not exceed 140 °C during the test
- The maximum temperature rise on the unexposed surface of the test specimen did not exceed 180 °C during the test

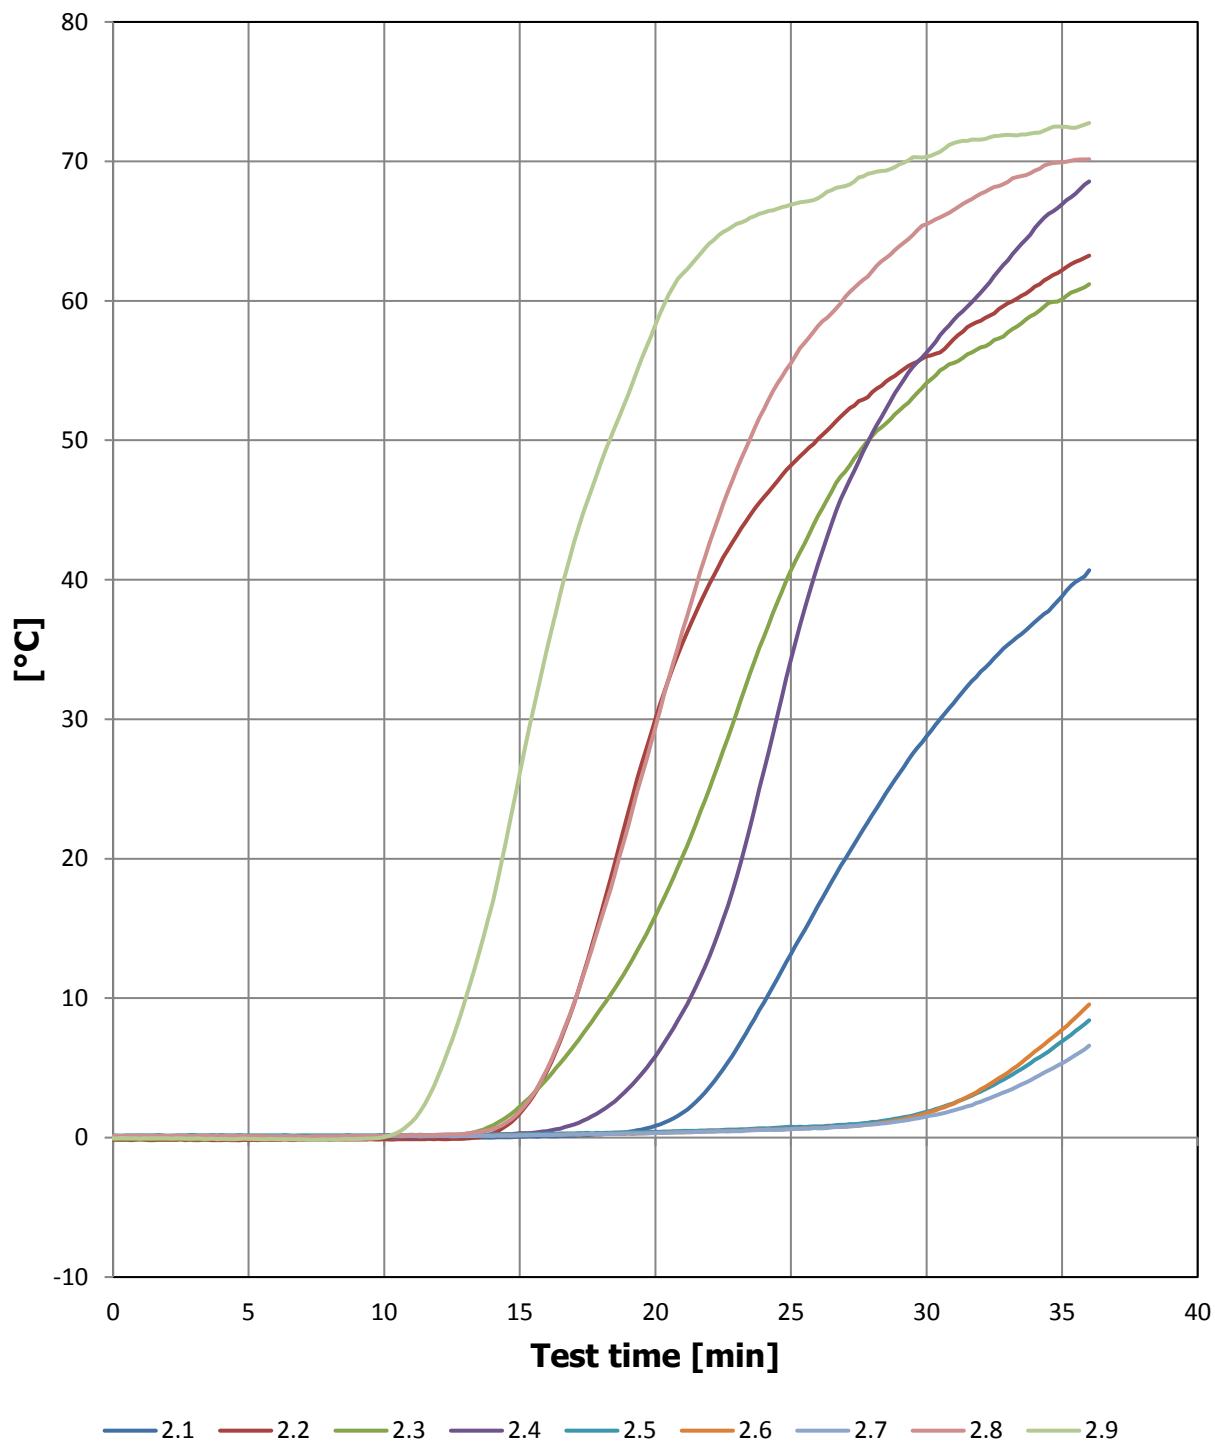
Maximum temperatures

Temperature rise on the unexposed side

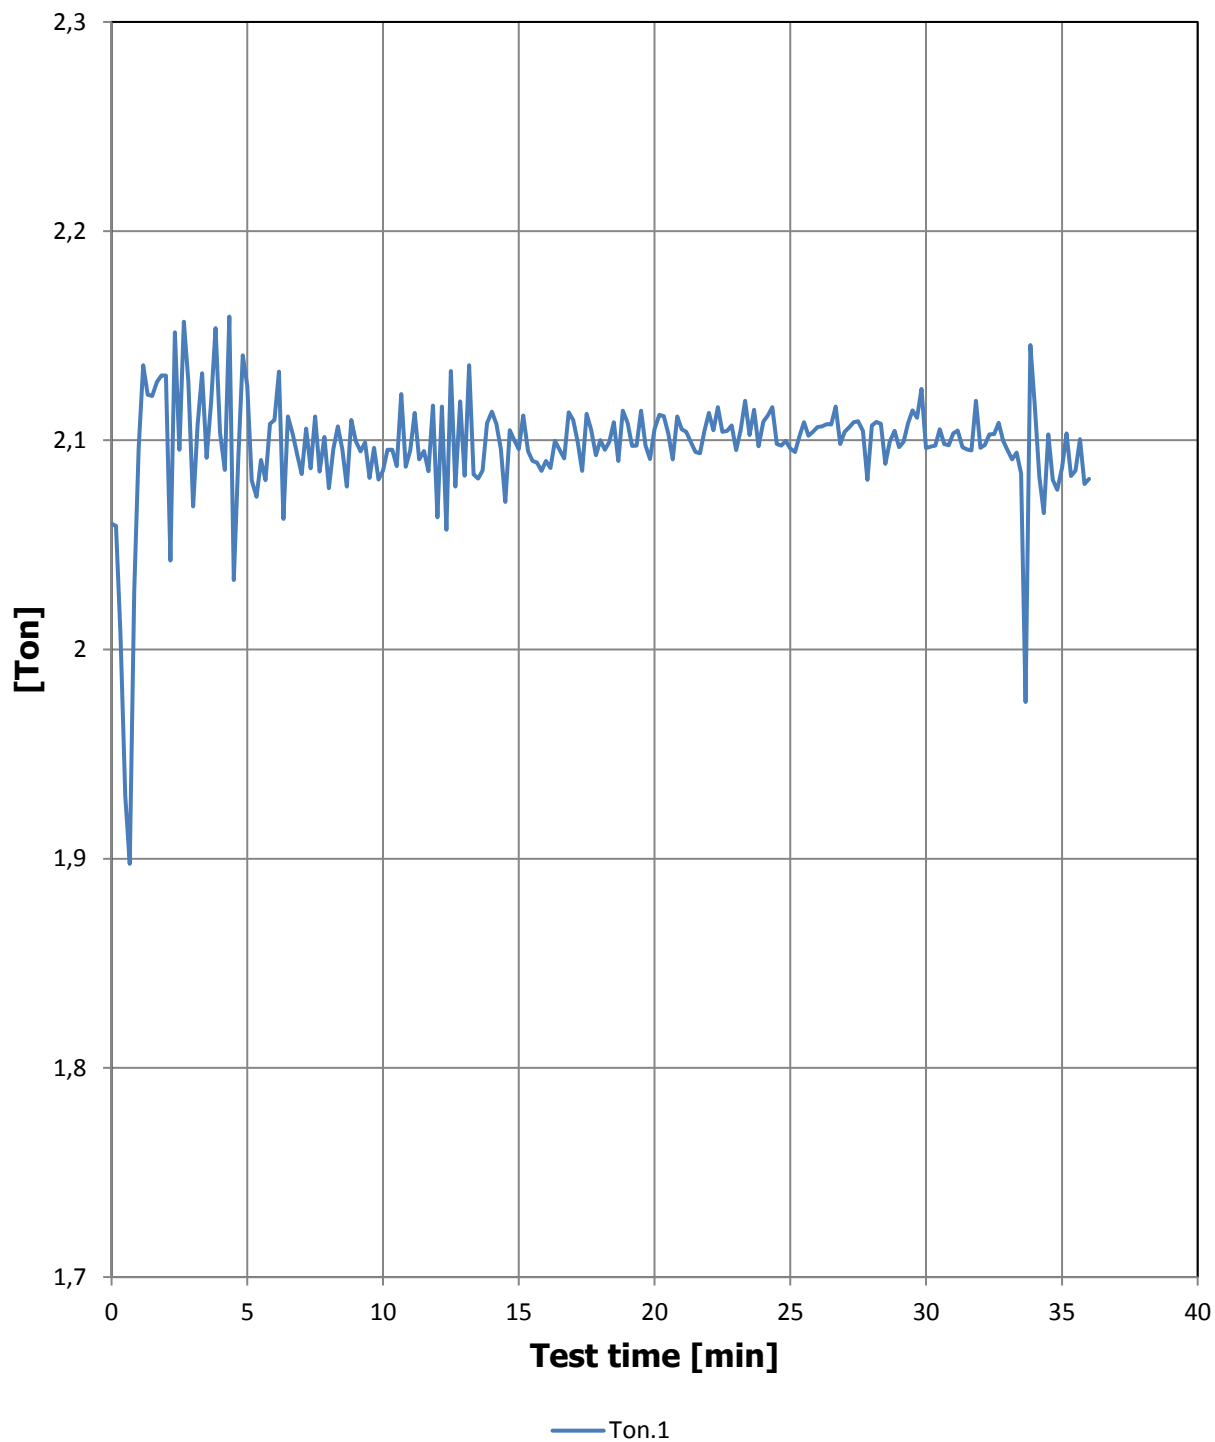
Load

The load on the deck during the test

Graph showing indication of load, determined from oil pressure measurement in piston

The load was applied as a downward oriented point load in the quarter sections of the deck, e.g. there was no eccentricity in the loading conditions.

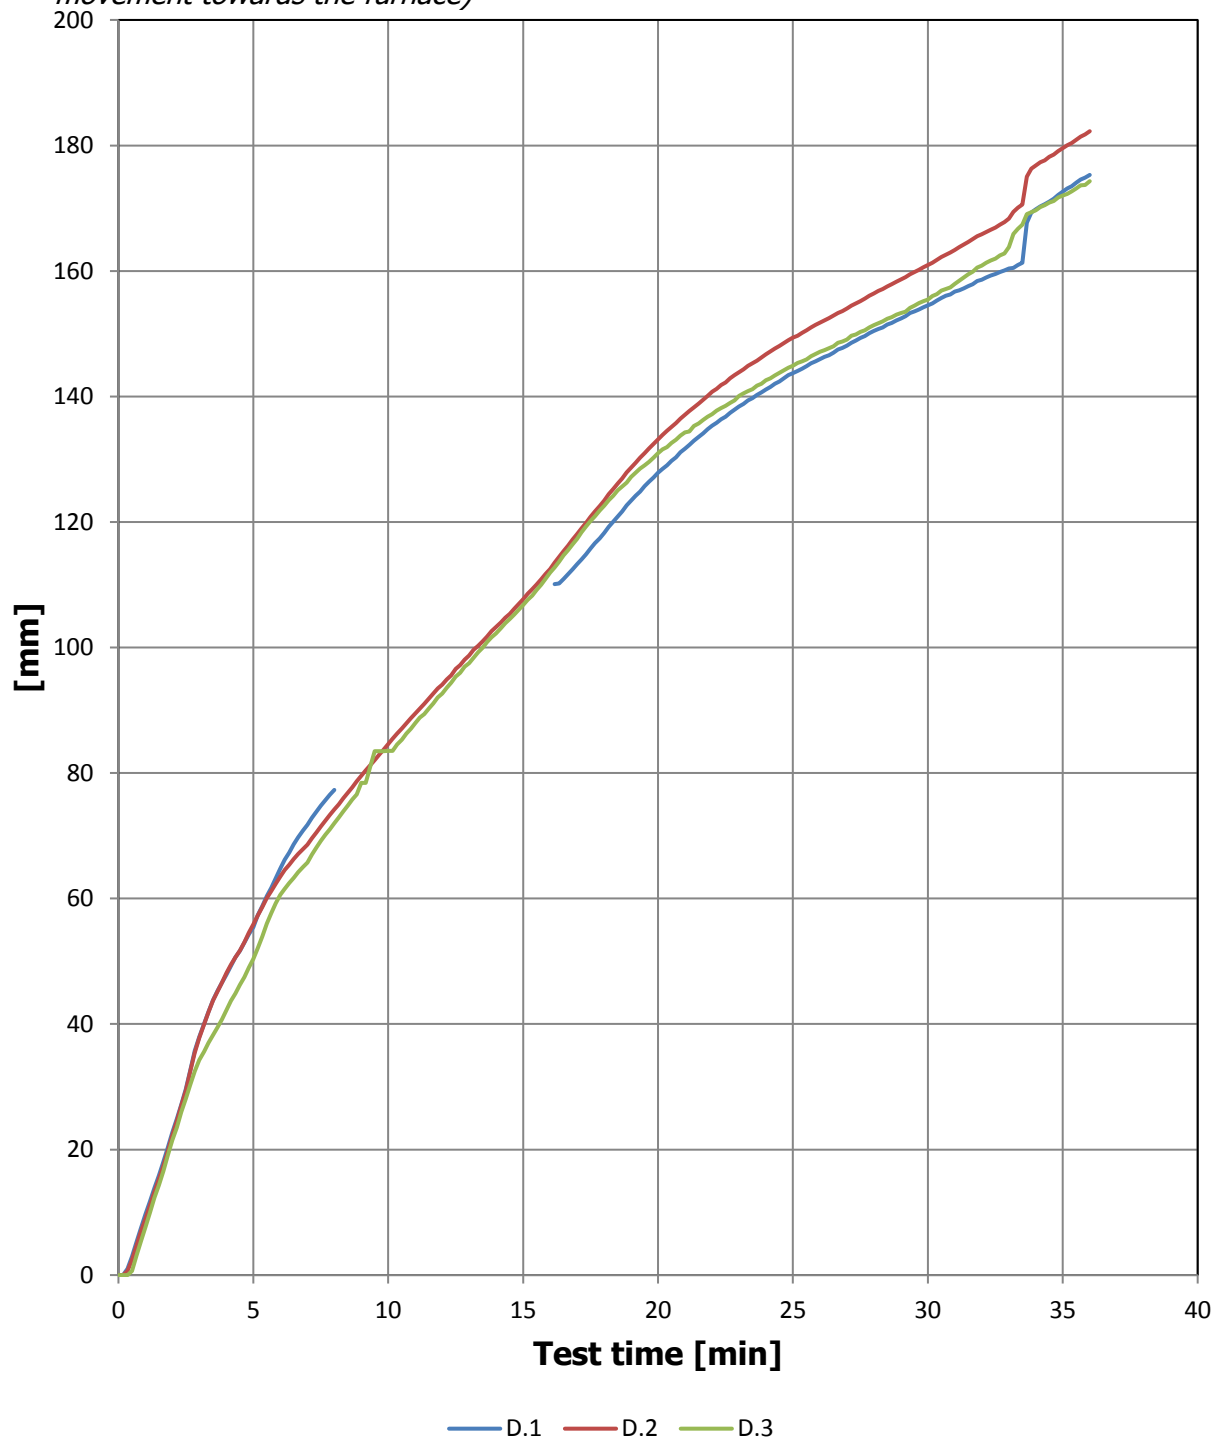
Deformation

The vertical deflection measured on the unexposed side (positive values indicates movement towards the furnace)

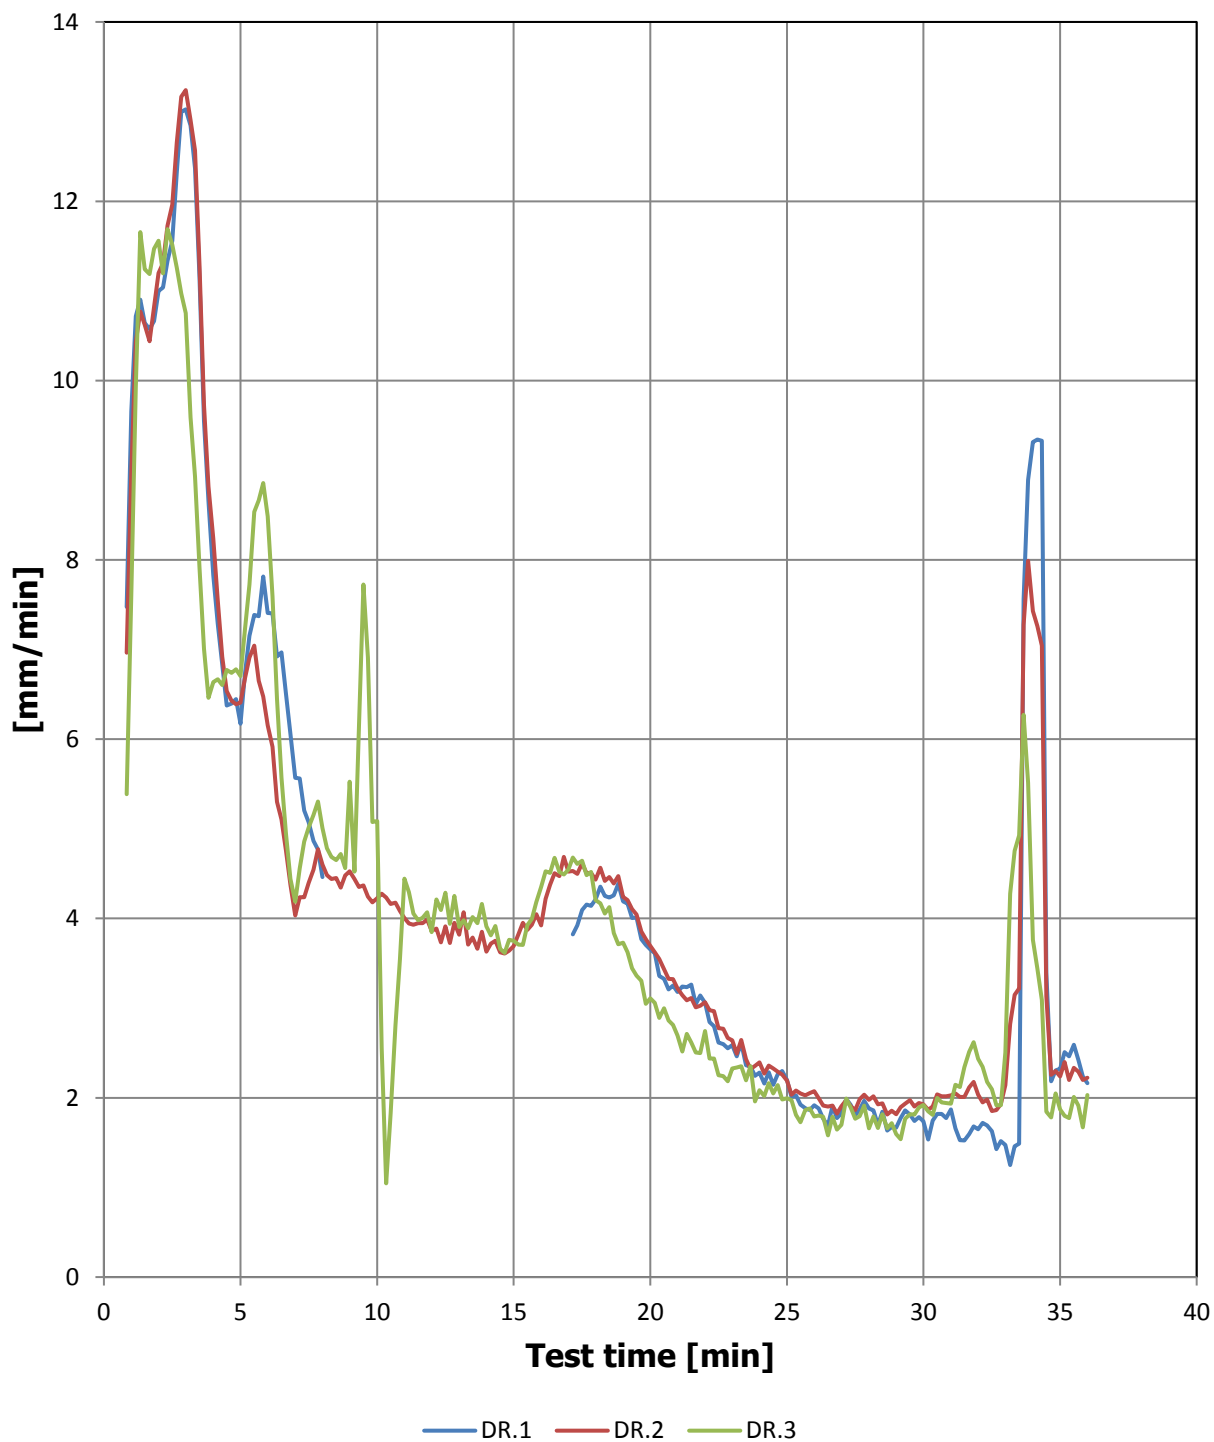
Deformation per minute

D1, D3: at the edges, D2: in the center

Note: according to EN 1363-1:2012 §11.1 the criteria for rate of deflection does not apply in the first 10 minutes of the fire test.

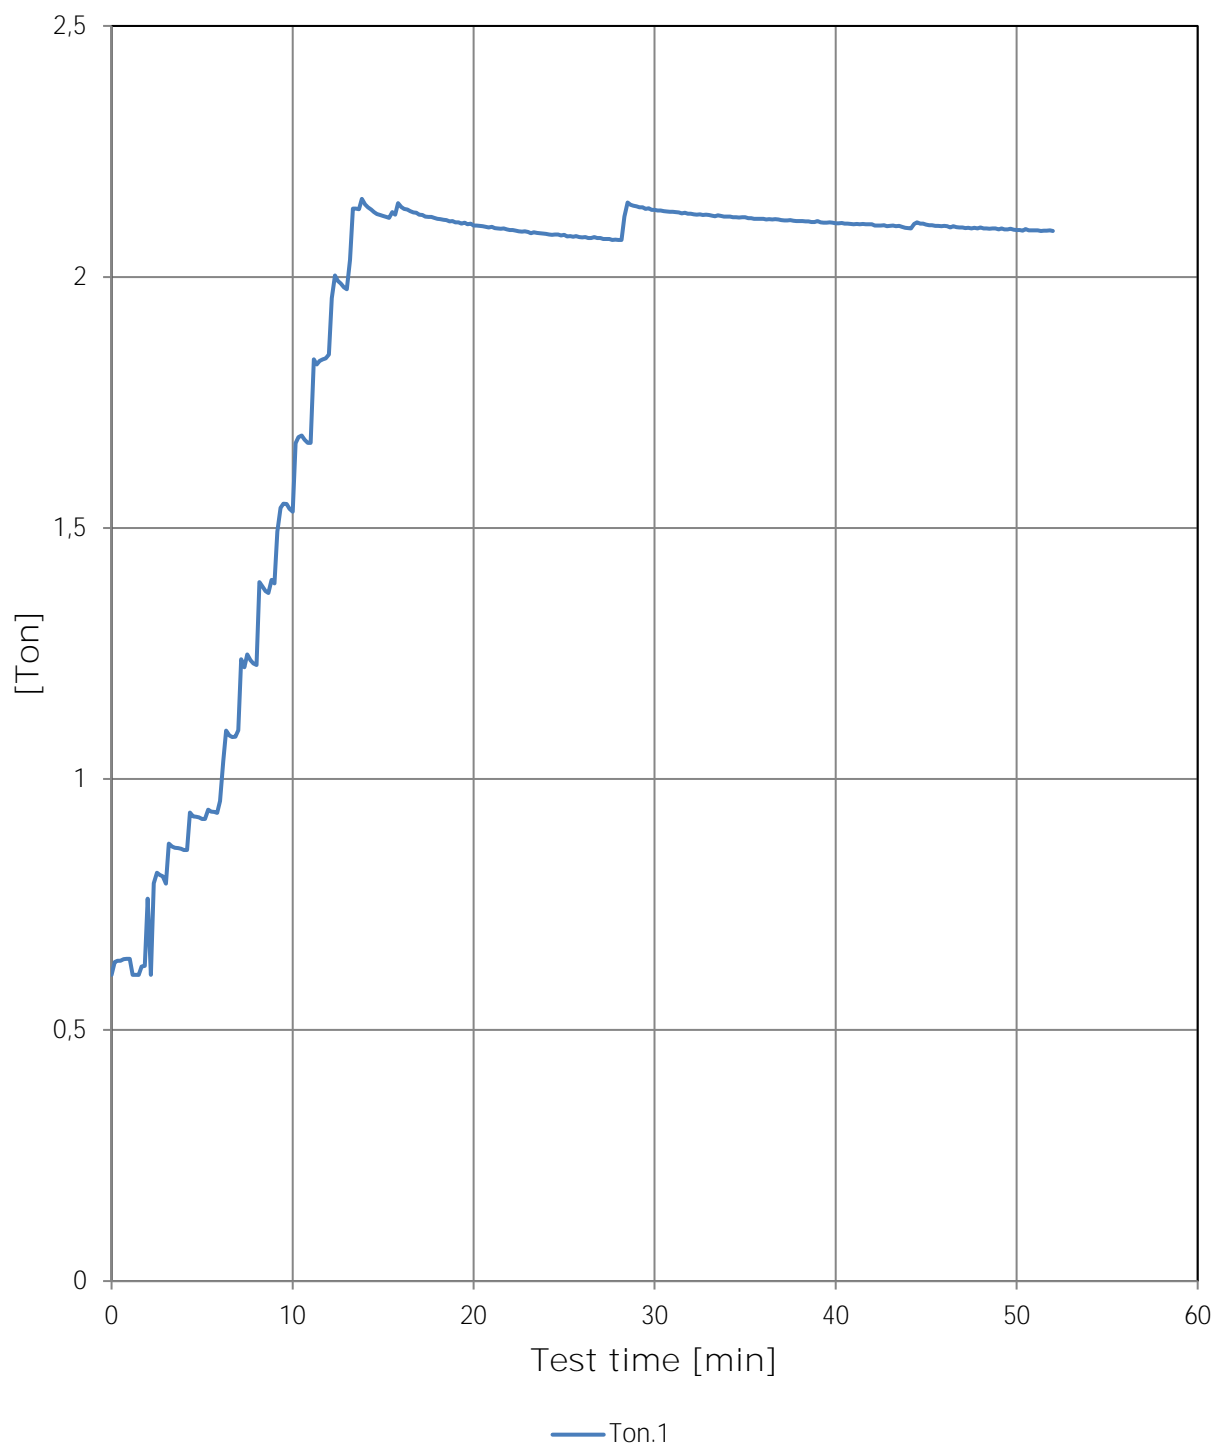
Load during loading phase

Total load prior to the test

Graph showing indication of load, determined from oil pressure measurement in piston

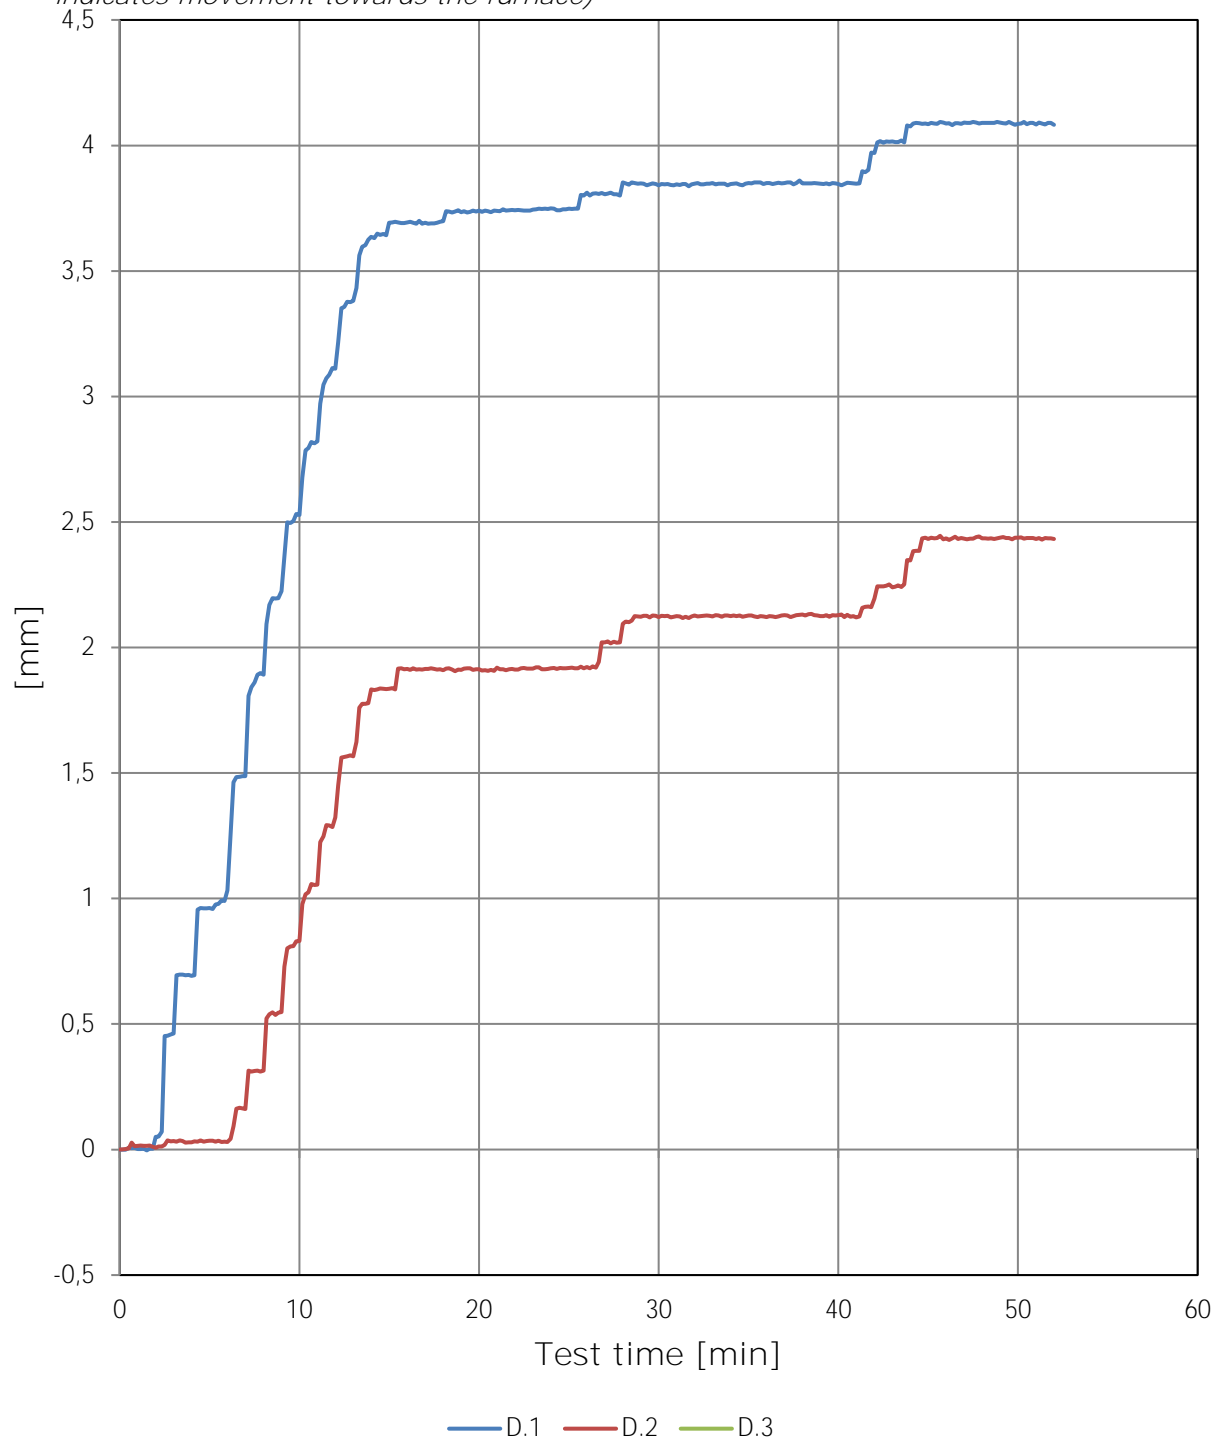
Deformation during loading phase

The vertical deflection measured prior to the test on the unexposed side (positive values indicates movement towards the furnace)
