Test Report

Loadbearing roof

Name of sponsor: Nordic Build A/S
Product name: Loadbearing roof
File no.: PGA11454A **Revision no.:** 0
Test date: 07-06-2019 **Date:** 03-07-2019
Pages: 11 **Encl.:** 56
Ref: RBI / NOL

Examination of the fire-resistance of a loadbearing and separating roof.

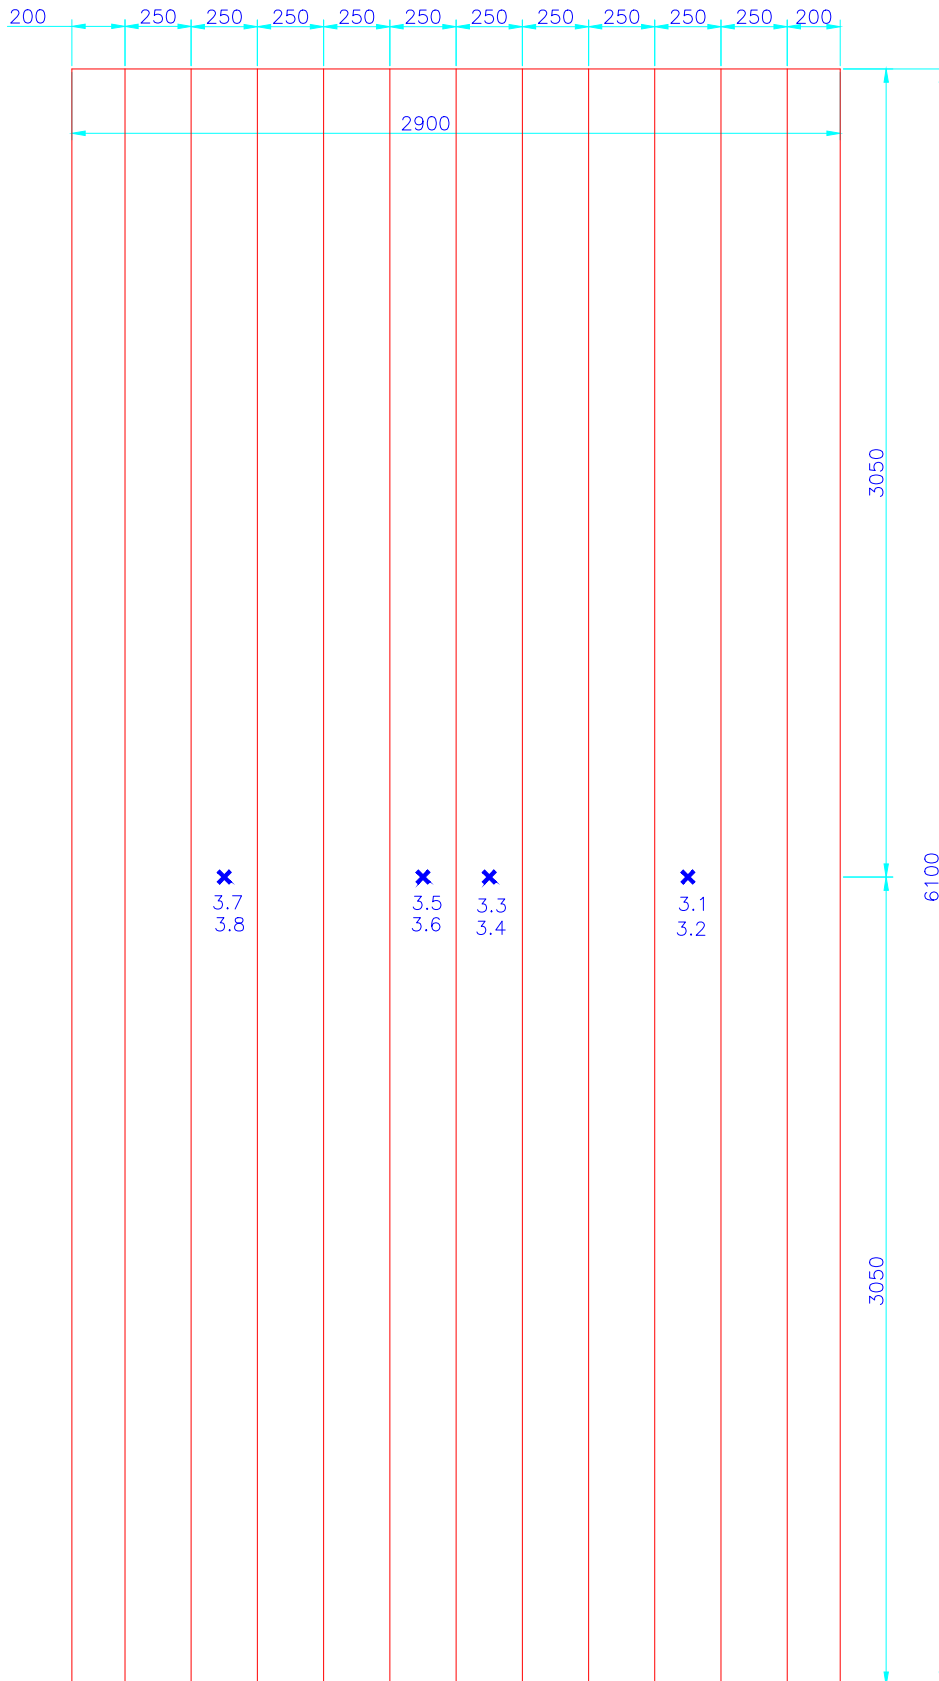
File No.: PGA11454A
Test date: 07-06-2019
Enclosure: 1.1

- ✘ Thermocouple placed inside the test specimen
A3.1, A3.3, A3.5, A3.7 placed 25 mm above lower visible edge of M4 composite board
A3.2, A3.4, A3.6, A3.8 placed mid height M4 composite board

All measurements are in mm

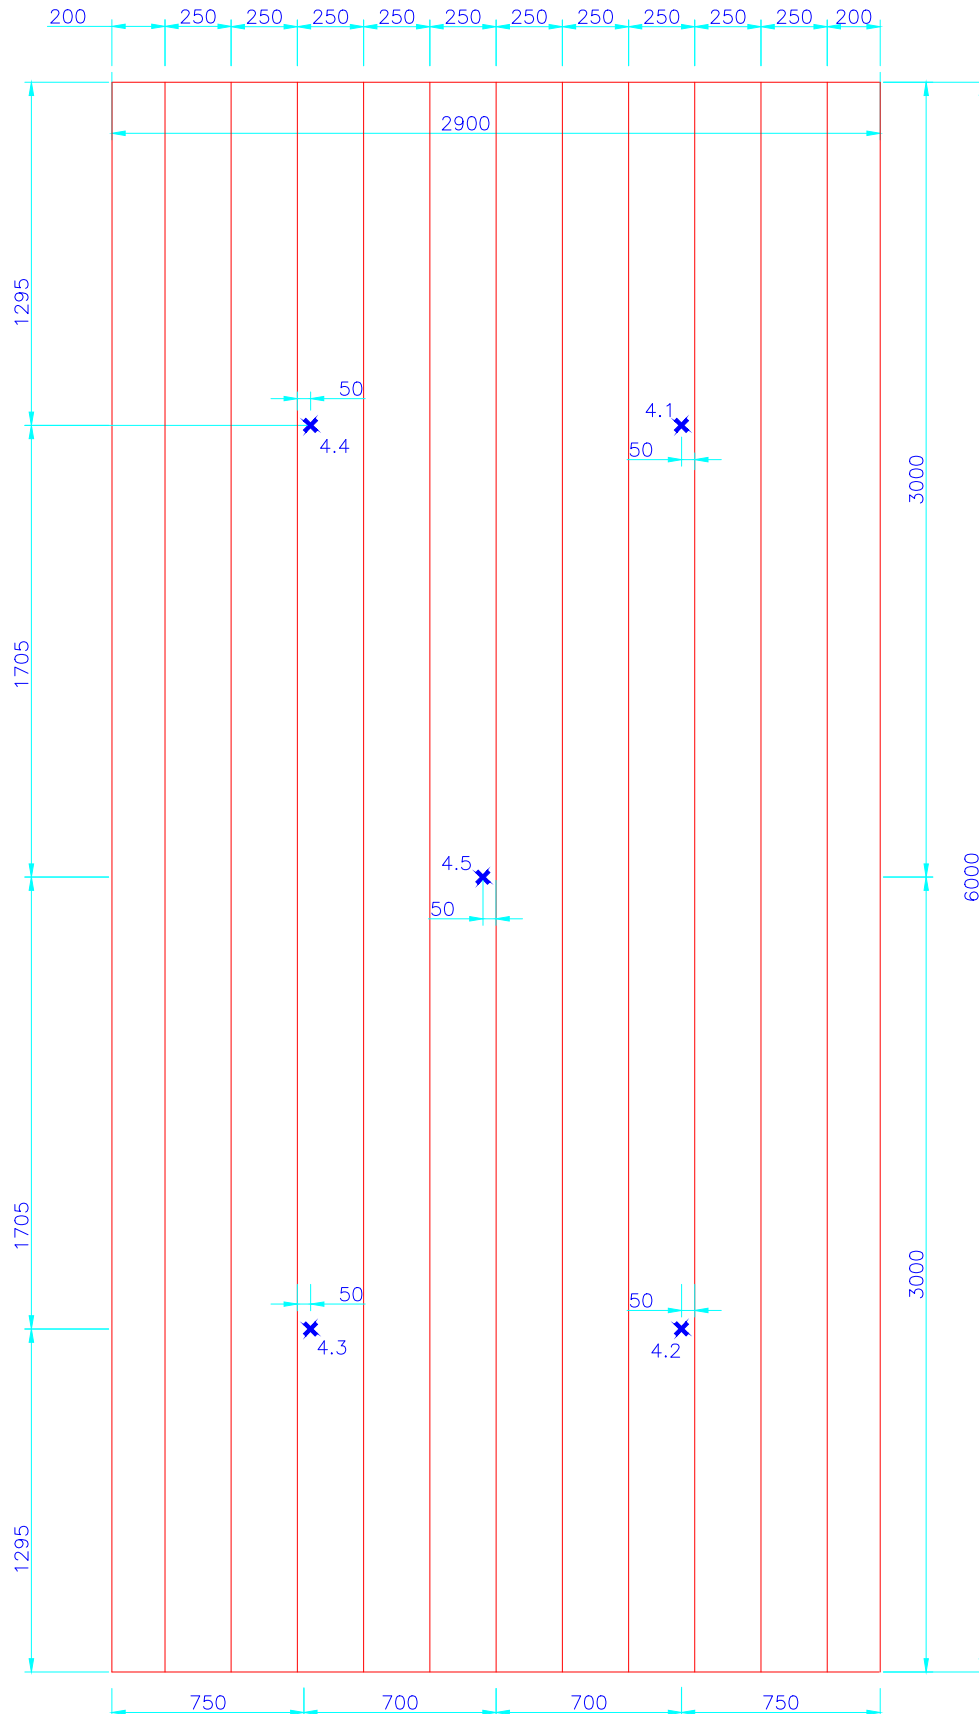
File No.: **PGA11454A**
Test date: 07-06-2019
Enclosure: 1.2

✘ Thermocouple placed on exposed side of the test specimen between the test specimen and the 2x15 mm gypsum boards

All measurements are in mm

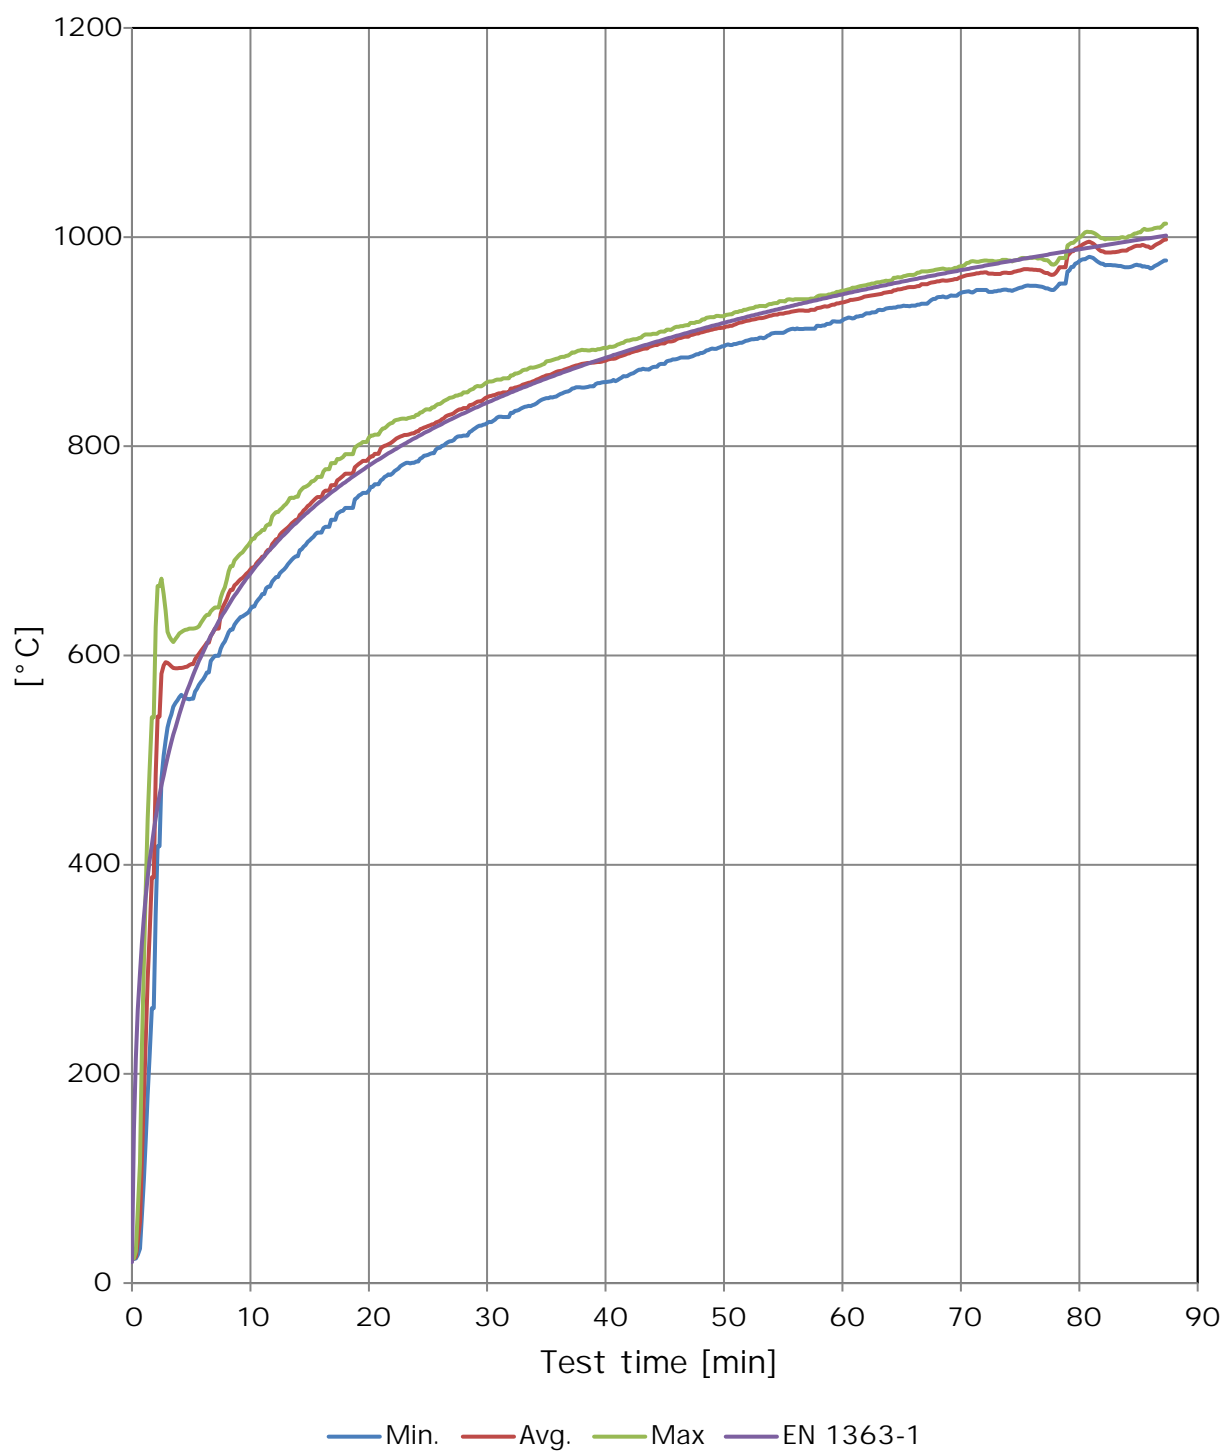
Furnace temperatures

Time Minutes	Measured			Norm EN 1363-1	Area under curve		Dev. [%]	Limit [%]
	Minimum	Average	Maximum		Measured	EN 1363-1		
0	23	23	24	20	0	0	0,0	
3	531	593	623	502	953	1115	-14,5	
6	577	607	634	603	2731	2790	-2,1	15
9	635	671	696	663	4647	4695	-1,0	15
12	673	709	735	705	6712	6750	-0,6	14
15	710	744	764	739	8891	8918	-0,3	13
18	741	774	792	766	11166	11176	-0,1	11
21	767	798	815	789	13519	13508	0,1	10
24	785	814	830	809	15940	15904	0,2	8
27	805	831	847	826	18407	18357	0,3	7
30	822	847	861	842	20923	20859	0,3	5
33	837	859	873	856	23480	23406	0,3	5
36	849	872	884	869	26076	25994	0,3	5
39	857	880	892	881	28706	28619	0,3	4
42	869	889	901	892	31357	31279	0,3	4
45	879	898	910	902	34040	33971	0,2	4
48	889	909	919	912	36751	36692	0,2	4
51	898	917	928	921	39489	39442	0,1	3
54	908	925	936	930	42253	42218	0,1	3
57	913	930	941	938	45037	45019	0,0	3
60	920	938	949	945	47838	47844	0,0	3
63	930	945	957	953	50663	50691	-0,1	3
66	935	952	964	960	53510	53559	-0,1	3

69	943	959	969	966	56378	56448	-0,1	3
72	949	966	978	973	59267	59356	-0,2	3
75	952	968	980	979	62165	62283	-0,2	3
78	951	966	975	985	65067	65228	-0,2	3
81	981	995	1005	990	68019	68190	-0,3	3
84	971	987	999	996	70981	71169	-0,3	3
87	976	996	1011	1001	73956	74164	-0,3	3

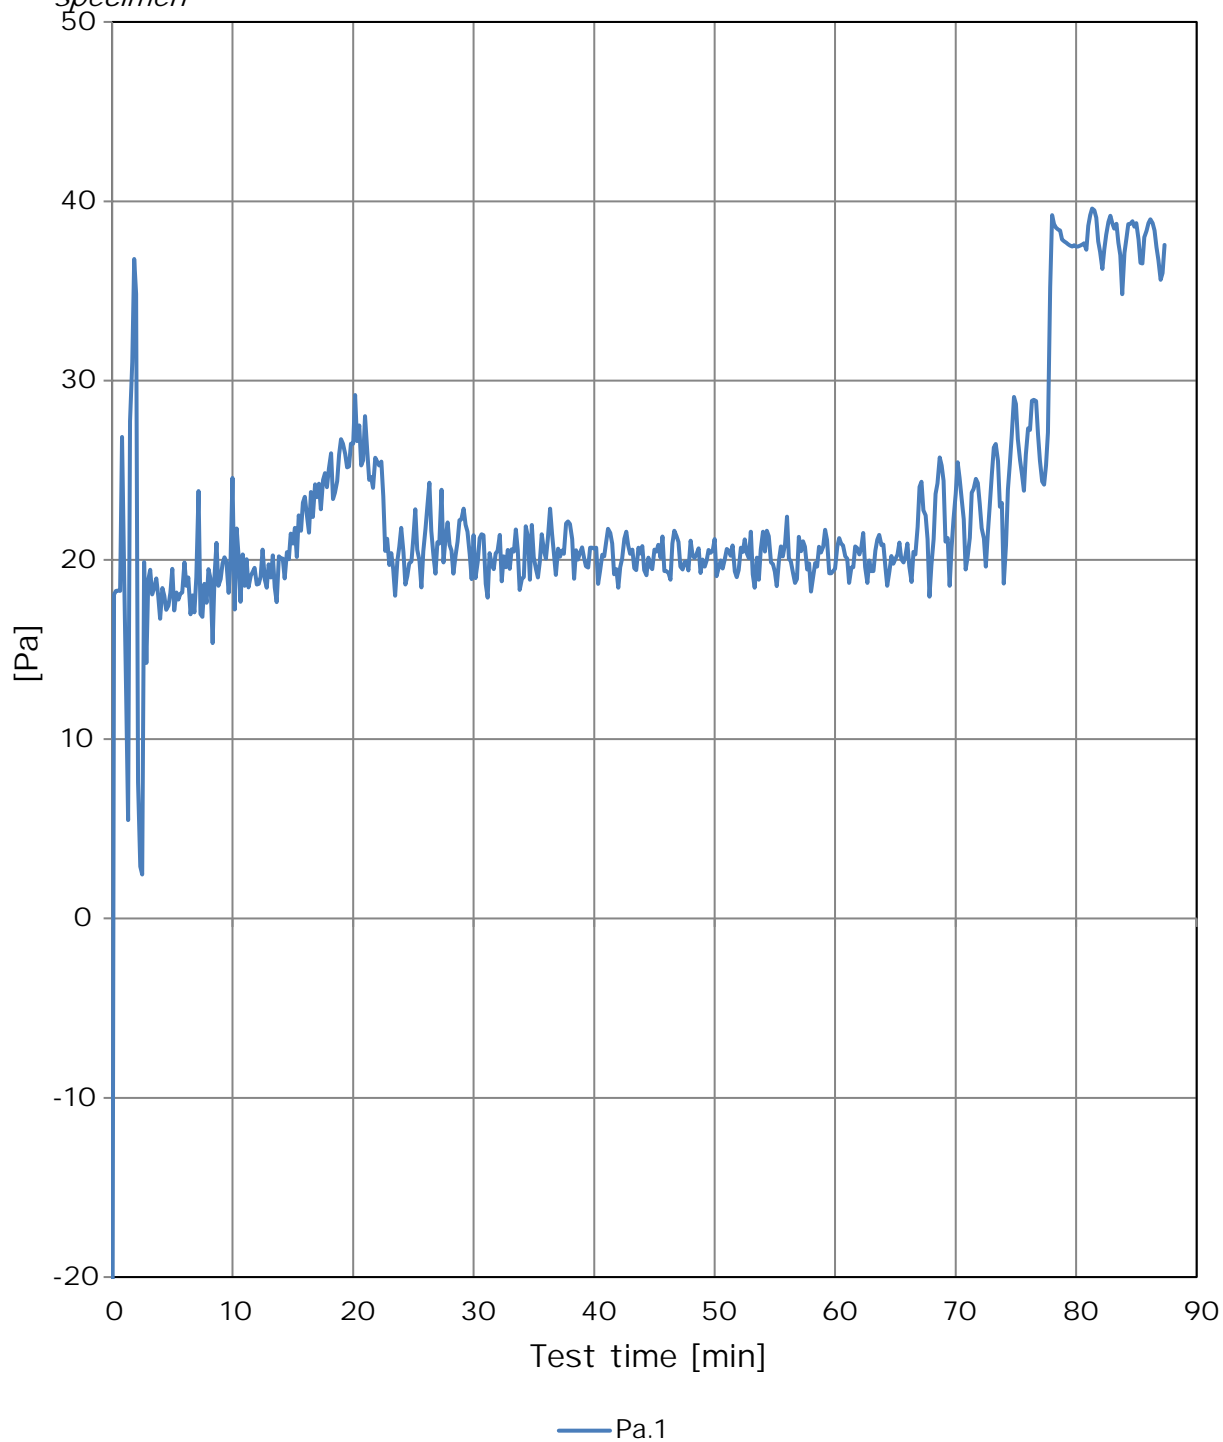
The differential pressure in the furnace during the test, measured 100 mm below specimen

Horizontal furnace pressure

Min. / Pa	Pa.1
0	-35,8
3	18,9
6	19,9
9	18,9
12	18,6
15	20,9
18	25,1
21	28,0
24	21,8
27	21,0
30	21,4
33	19,5
36	20,1
39	20,7
42	18,4
45	20,6
48	21,1
51	20,6
54	21,6
57	21,3
60	19,5
63	19,4
66	20,9
69	24,4
72	23,1
75	28,7
78	39,2
81	38,6
84	37,1
87	35,6

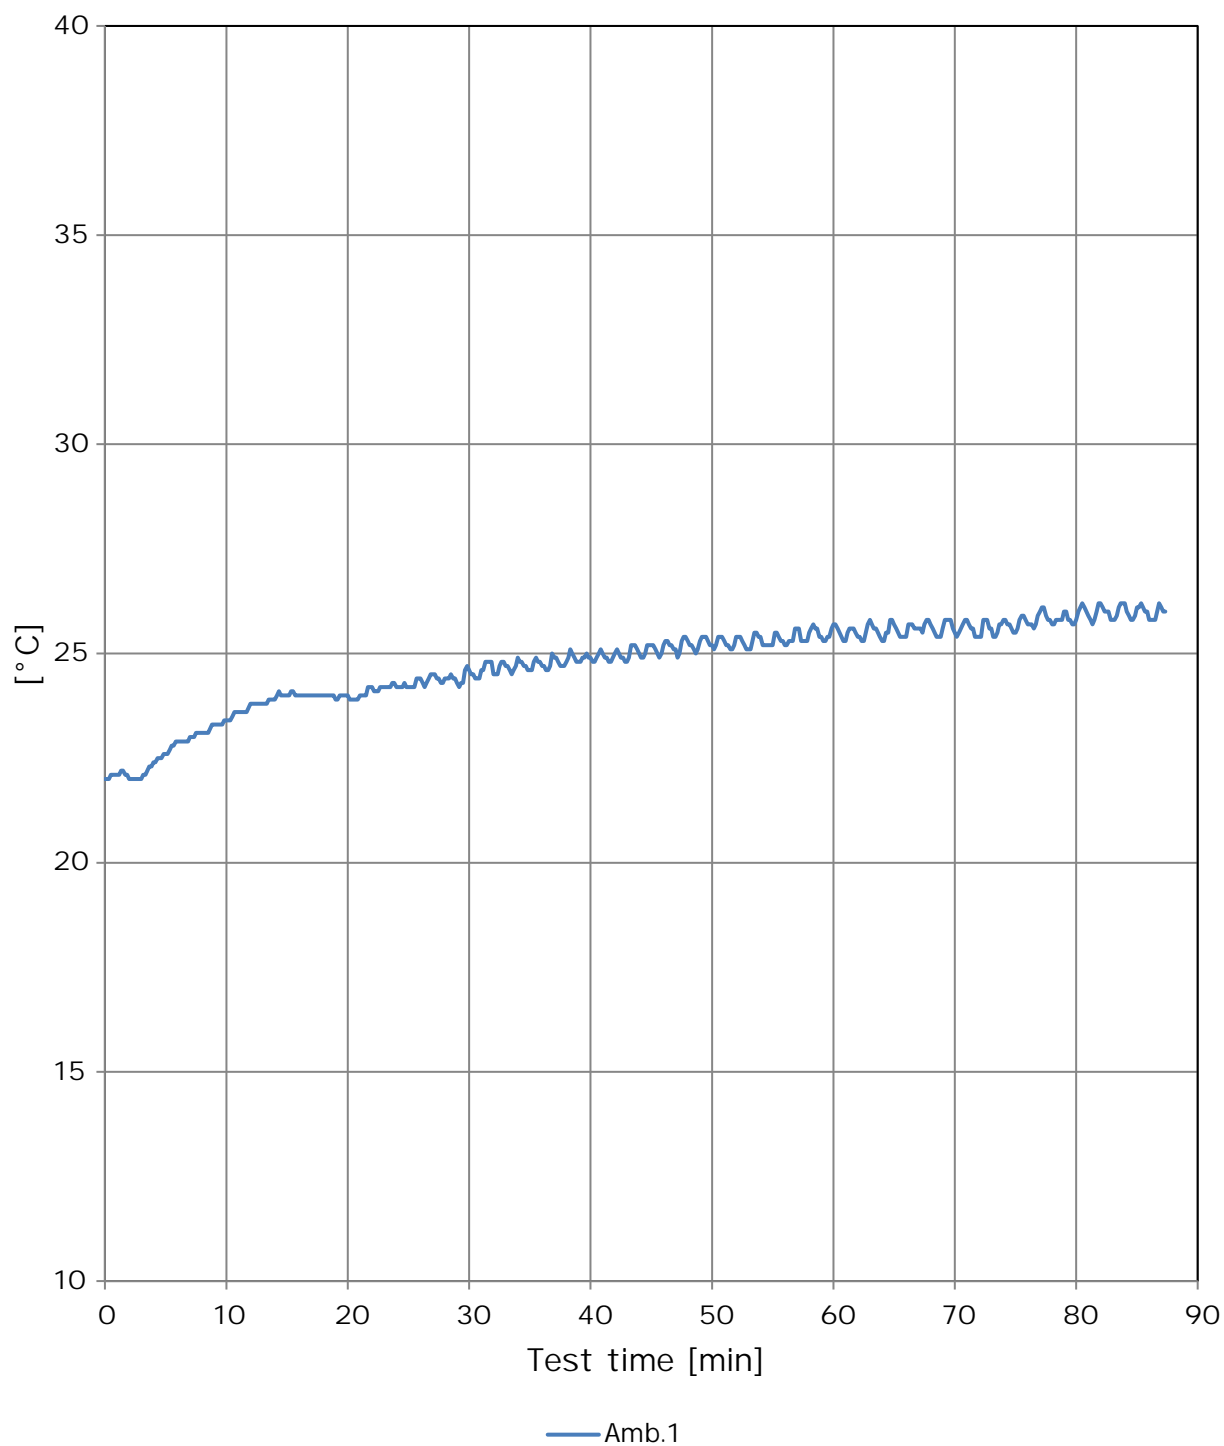
The ambient temperature in the laboratory during the test

Ambient temperature

Min. / °C	Amb.1
0	22,0
3	22,0
6	22,9
9	23,3
12	23,8
15	24,0
18	24,0
21	24,0
24	24,2
27	24,5
30	24,6
33	24,7
36	24,7
39	24,8
42	25,0
45	25,2
48	25,3
51	25,3
54	25,4
57	25,6
60	25,7
63	25,8
66	25,4
69	25,6
72	25,4
75	25,5
78	25,7
81	25,9
84	26,2
87	26,1

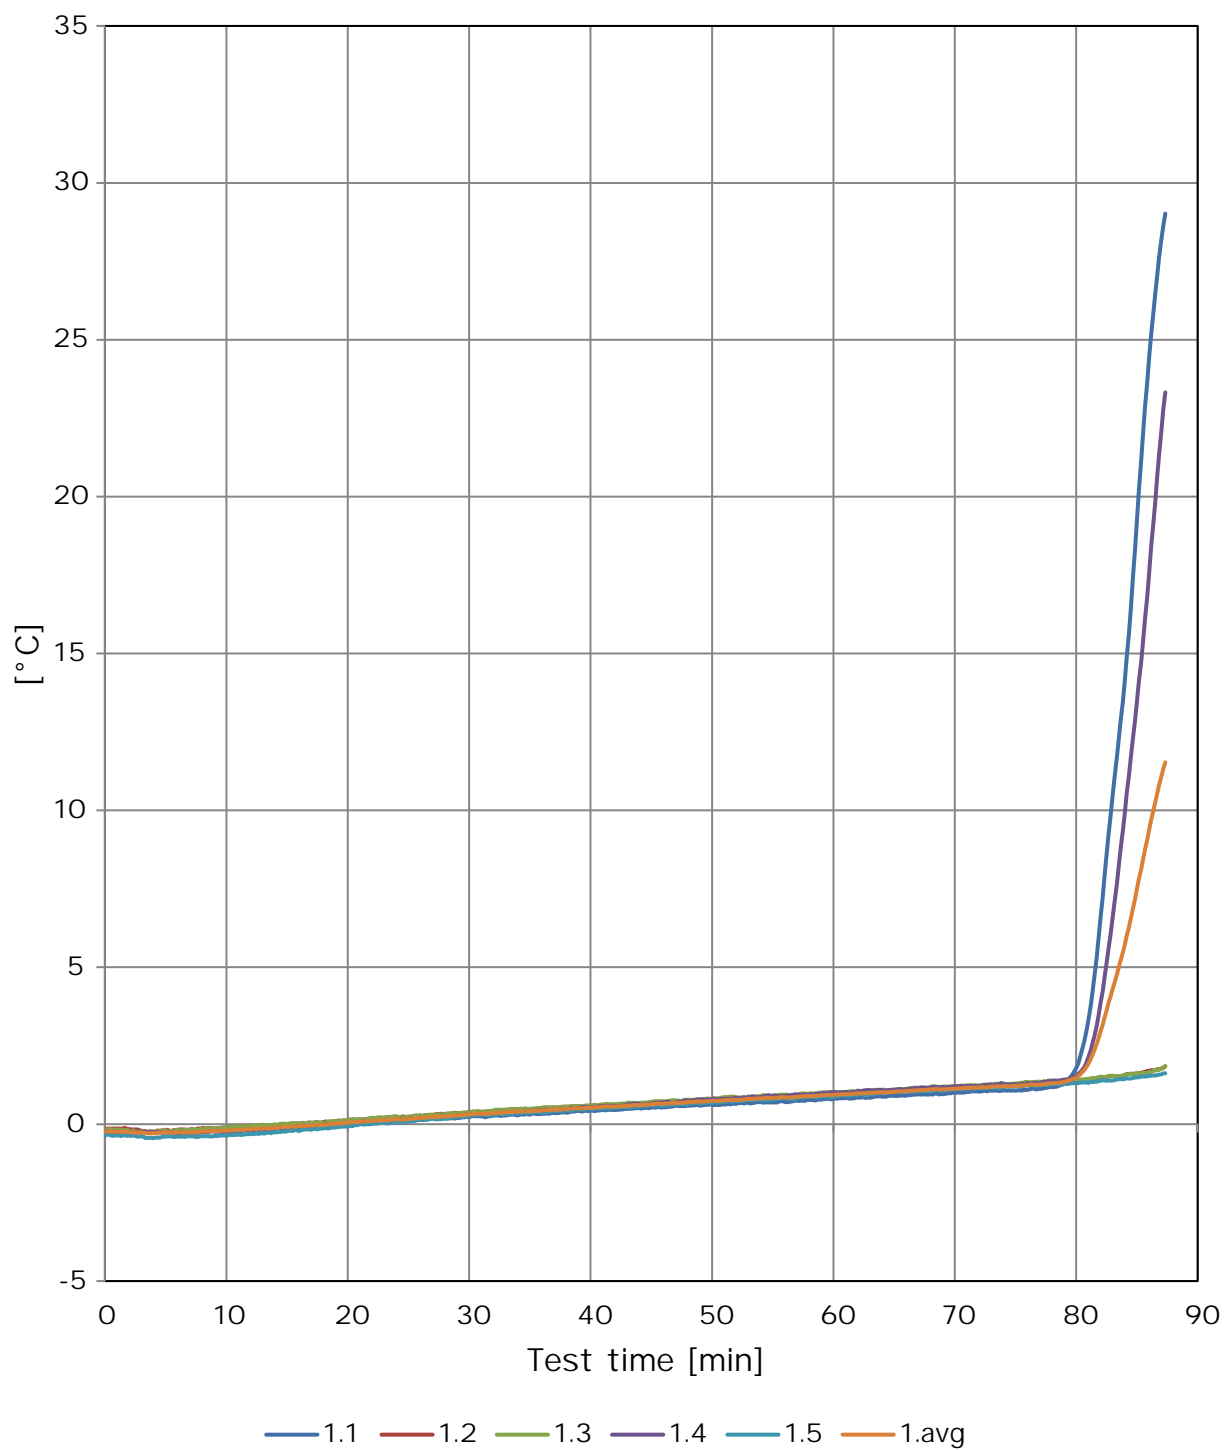
Temperature rise on the unexposed side

Average temperature

Min. / °C	1.1	1.2	1.3	1.4	1.5	1.Avg	1.Max
0	0	0	0	0	0	0	0
3	0	0	0	0	0	0	0
6	0	0	0	0	0	0	0
9	0	0	0	0	0	0	0
12	0	0	0	0	0	0	0
15	0	0	0	0	0	0	0
18	0	0	0	0	0	0	0
21	0	0	0	0	0	0	0
24	0	0	0	0	0	0	0
27	0	0	0	0	0	0	0
30	0	0	0	0	0	0	0
33	0	0	0	0	0	0	0
36	0	0	1	0	0	0	1
39	0	1	1	1	0	1	1
42	0	1	1	1	1	1	1
45	1	1	1	1	1	1	1
48	1	1	1	1	1	1	1
51	1	1	1	1	1	1	1
54	1	1	1	1	1	1	1
57	1	1	1	1	1	1	1
60	1	1	1	1	1	1	1
63	1	1	1	1	1	1	1
66	1	1	1	1	1	1	1
69	1	1	1	1	1	1	1
72	1	1	1	1	1	1	1
75	1	1	1	1	1	1	1
78	1	1	1	1	1	1	1
81	3	1	1	2	1	2	3
84	14	2	2	10	1	6	14
87	28	2	2	22	2	11	28

Failure [min]	-	-	-	-	-	-	-
Failure [°C]	180	180	180	180	180	140	180

- During the test no failure of insulation occurred to failure of integrity
- The average temperature rise on the unexposed surface of the test specimen did not exceed 140 °C during the test
- The maximum temperature rise on the unexposed surface of the test specimen did not exceed 180 °C during the test
-

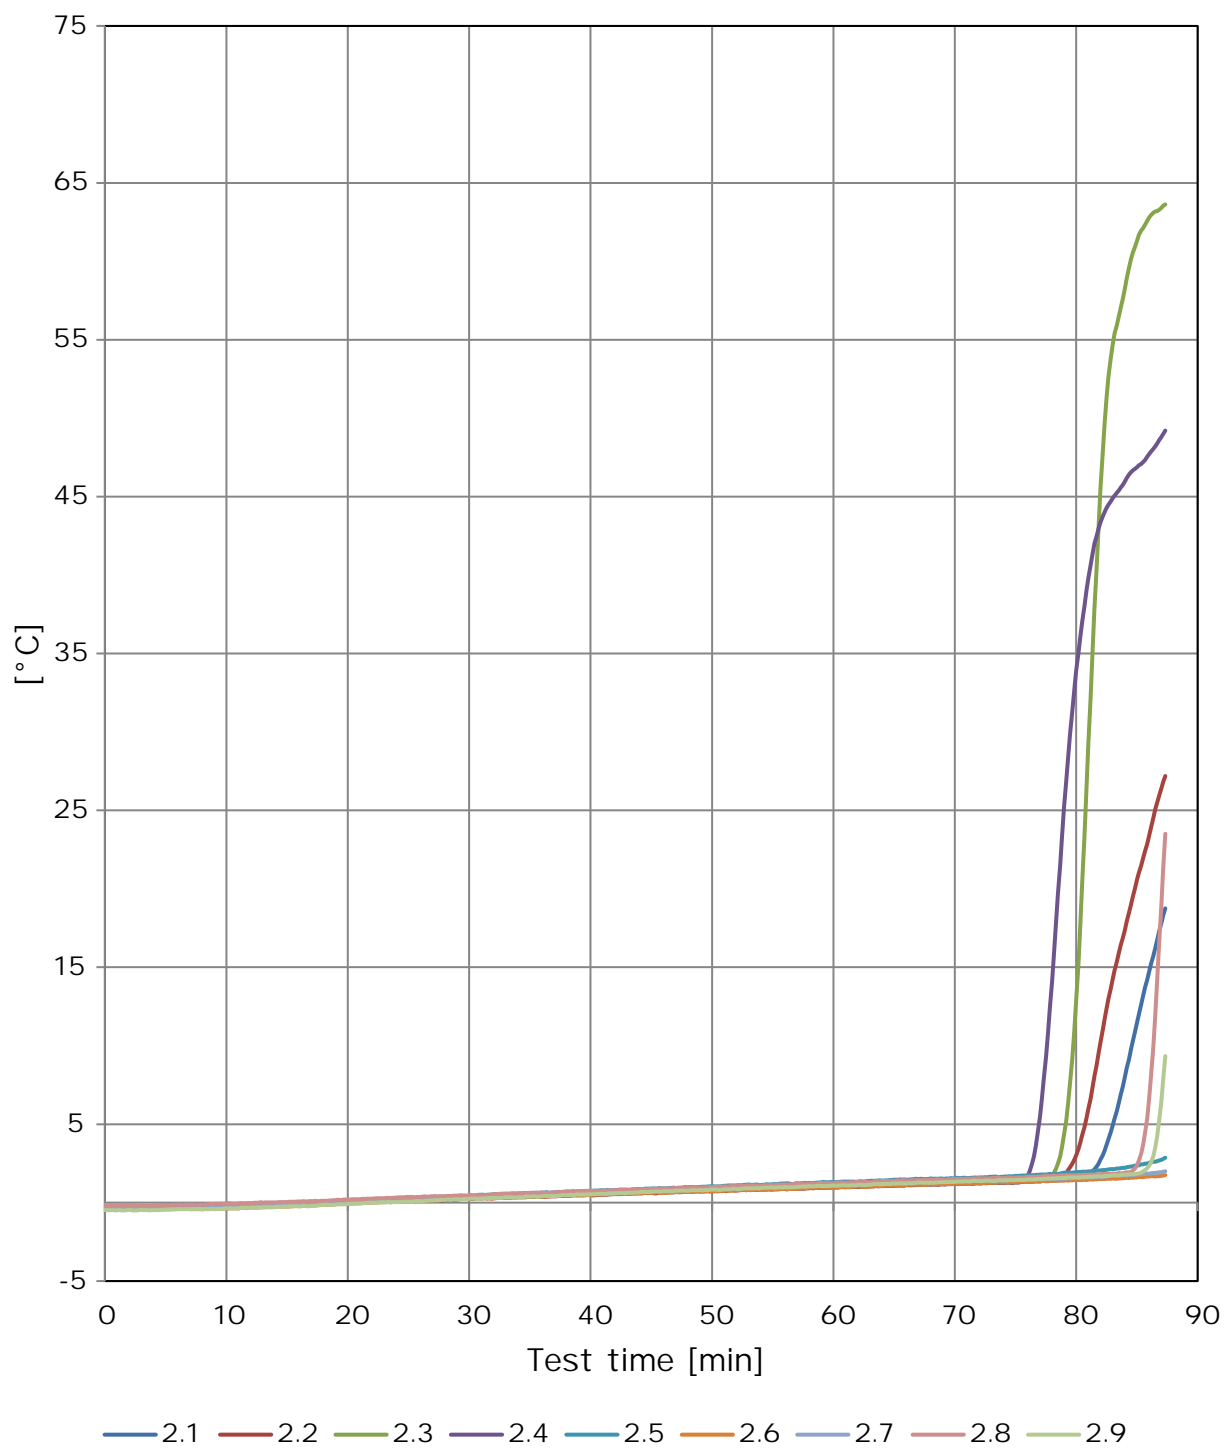
Temperature rise on the unexposed side

Maximum temperatures

Failure [min]	-	-	-	-	-	-	-	-	-	-
Failure [°C]	180	180	180	180	180	180	180	180	180	180

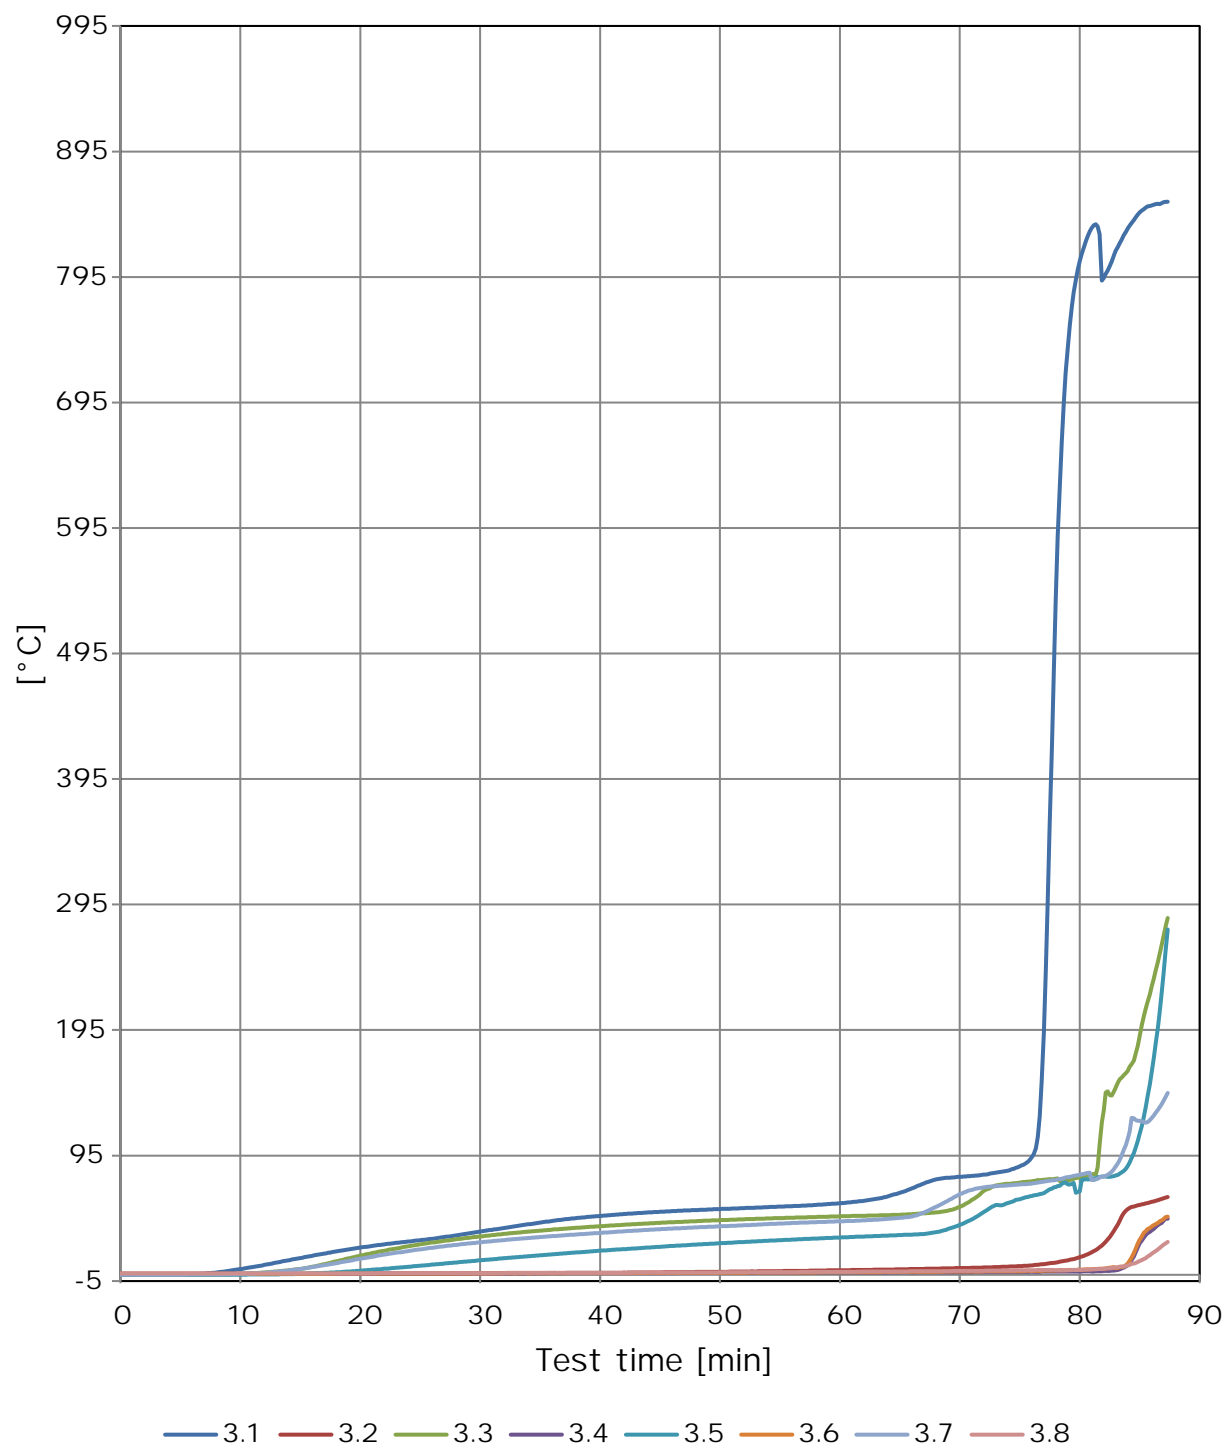
Temperature rise inside the test specimen

Internal indicative temperatures

Failure [min]	76,83	-	84,67	-	86,17	-	-	-	76,83
Failure [°C]	180	180	180	180	180	180	180	180	180

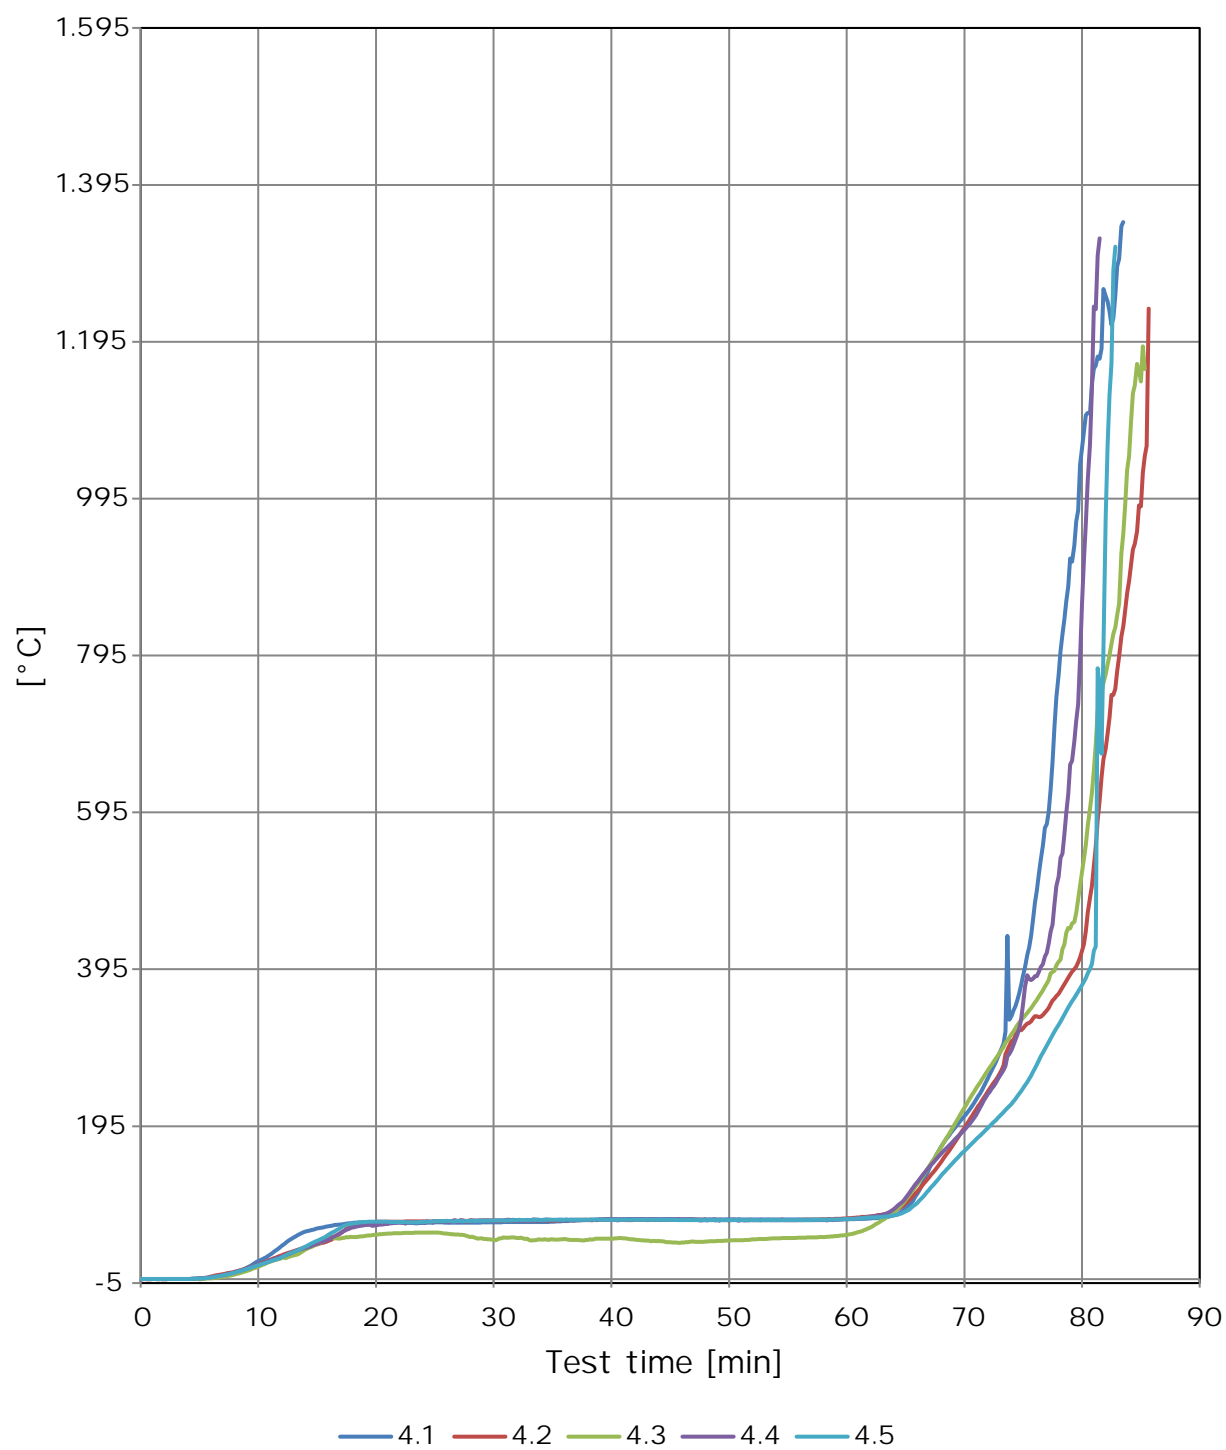
Temperature rise inside the test specimen

Internal indicative temperatures

Failure [min]	68,50	69,33	68,50	69,33	71,00	68,50
Failure [°C]	180	180	180	180	180	180
